ACCIDENT REPORT

5Y-UVP

22.08.2012

AIR ACCIDENT INVESTIGATION DEPARTMENT

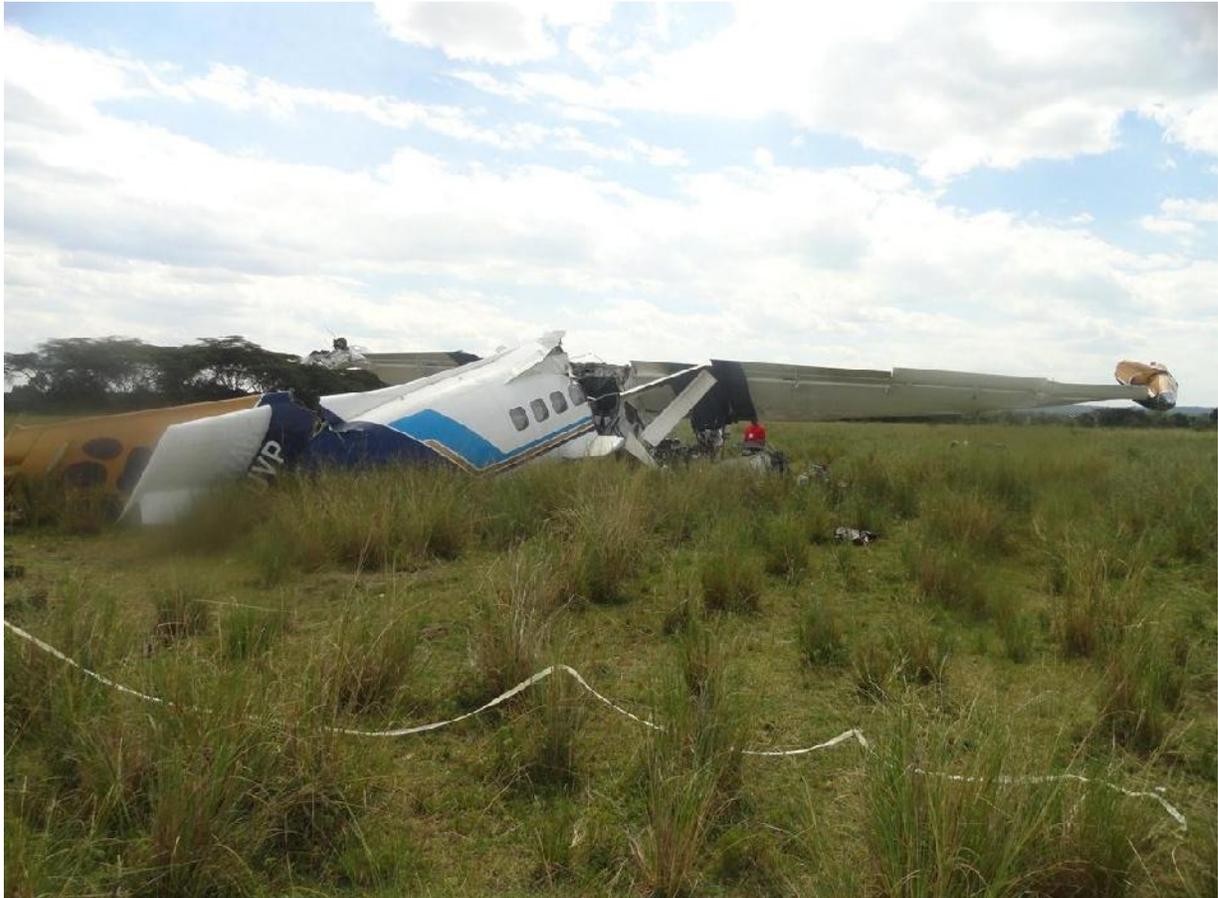
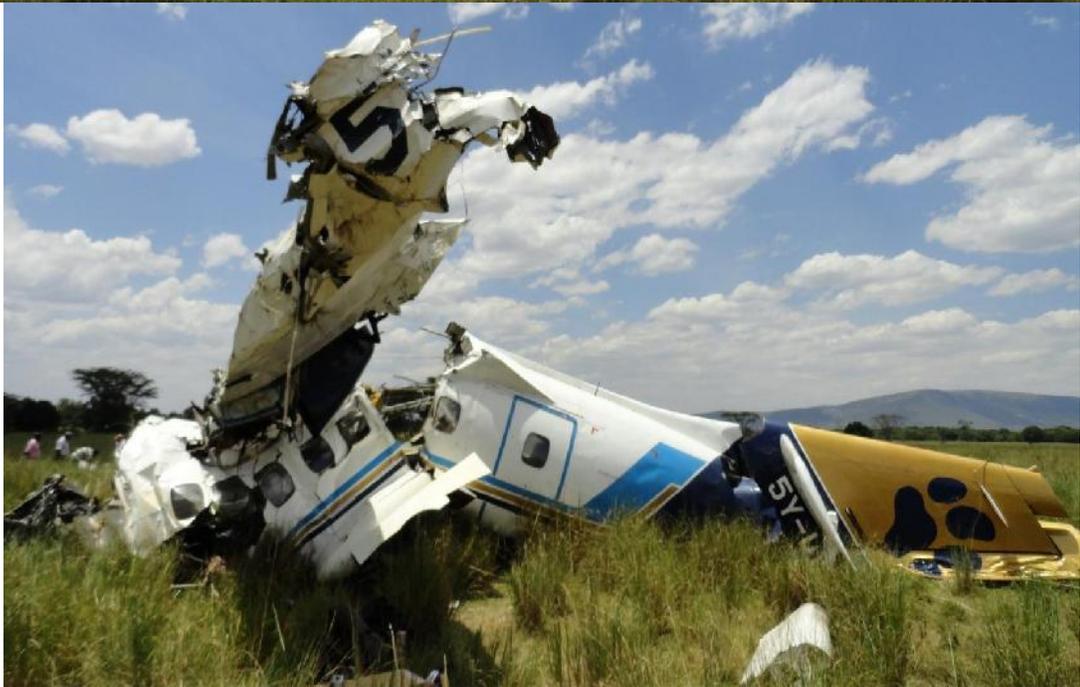
figure 1.1 accident site with the wreckage of 5Y-UVP

First responders reported the front/cockpit was completely destroyed. The passenger cabin had sustained severe damage.

The Aircraft was completely destroyed after it collided with terrain. No fire ensued afterwards.

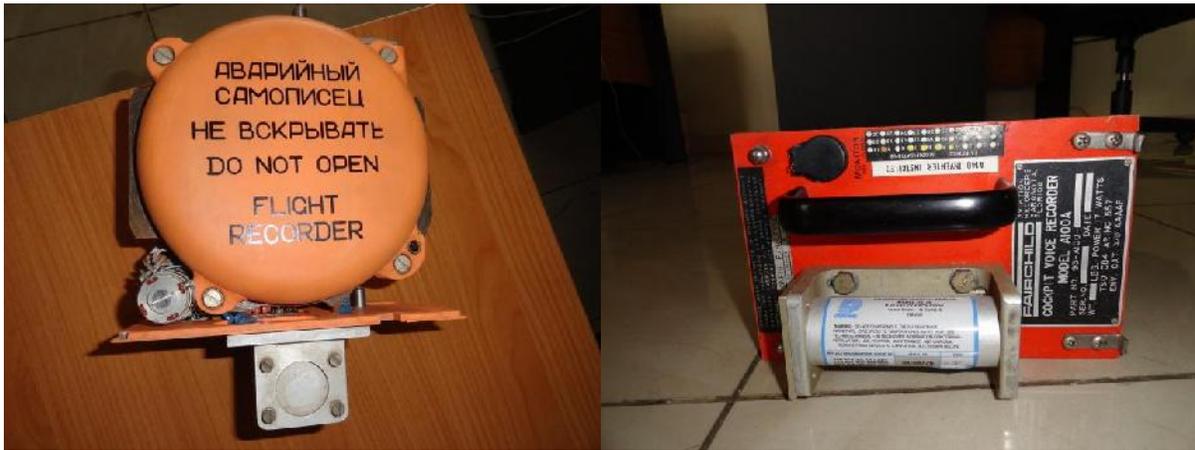
Fig 1.11.1: Flight data recorder & cockpit voice recorder recovered from the 5Y-UVP

The FDR of the aircraft LET-410 during the flight on August 22, 2012 was not serviceable and did not record any data pertinent to the accident flight. A copy of the FDR data was made and presented to AAID.

The CVR of the aircraft LET-410 during the flight on August 22, 2012 was not serviceable and did not record any data pertinent to the accident flight. The magnetic recording tape was severed and the drive unit assembly was also not serviceable. A copy of the CVR data was done and presented to AAID.

- i. KCAA to enforce the provisions of Kenya Civil Aviation Instruments and Equipment Regulations, specifically Part VI, regulation 36 and 37 and related sections
- ii. KCAA to consider inclusion of the aforementioned provisions in certificate of airworthiness inspection checklists
- iii. KCAA ascertain that aircraft in MAS are maintained in accordance with applicable laws, including but not limited to verification that facilities (AMOs) that carry out maintenance on MAS aircraft are duly approved.
- iv. Enhance training on single engine operation for twin engine aircraft, VMC roll procedures and other emergencies
- v. KCAA to establish an inspection program for aircraft fuel
- vi. KCAA to draw the attention of MAS and the industry at large to the provisions of ICAO Annex 6 – Operation of Aircraft, Chapter 6 dealing with the discontinuation of magnetic tape FDR/CVR
