AIR ACCIDENT INVESTIGATION

PRELIMINARY REPORT

OPERATOR:	Penial Air Ltd
AIRCRAFT TYPE/ MANUFACTURER:	C208/ Cessna Aircraft Company
YEAR OF MANUFACTURE:	1992
AIRCRAFT REGISTRATION:	5Y-SAV
AIRCRAFT SERIAL NUMBER:	0312
DATE OF REGISTRATION:	29 July 2016
NUMBER AND TYPE OF ENGINE:	Two Pratt & Whitney PT6A-114
DATE OF OCCURRENCE:	11 April 2018
TIME OF OCCURRENCE:	1405
LOCATION OF OCCURRENCE:	El Barde
TYPE OF FLIGHT:	Commercial
NUMBER OF PERSONS ON BOARD:	Fourteen
INJURIES:	None
NATURE OF DAMAGE:	Port horizontal stabilizer and elevator damage
CATEGORY OF OCCURRENCE:	Incident
PIC FLYING EXPERIENCE:	Total Time: ~15,500 hrs (On Type: ~1,000 hrs)

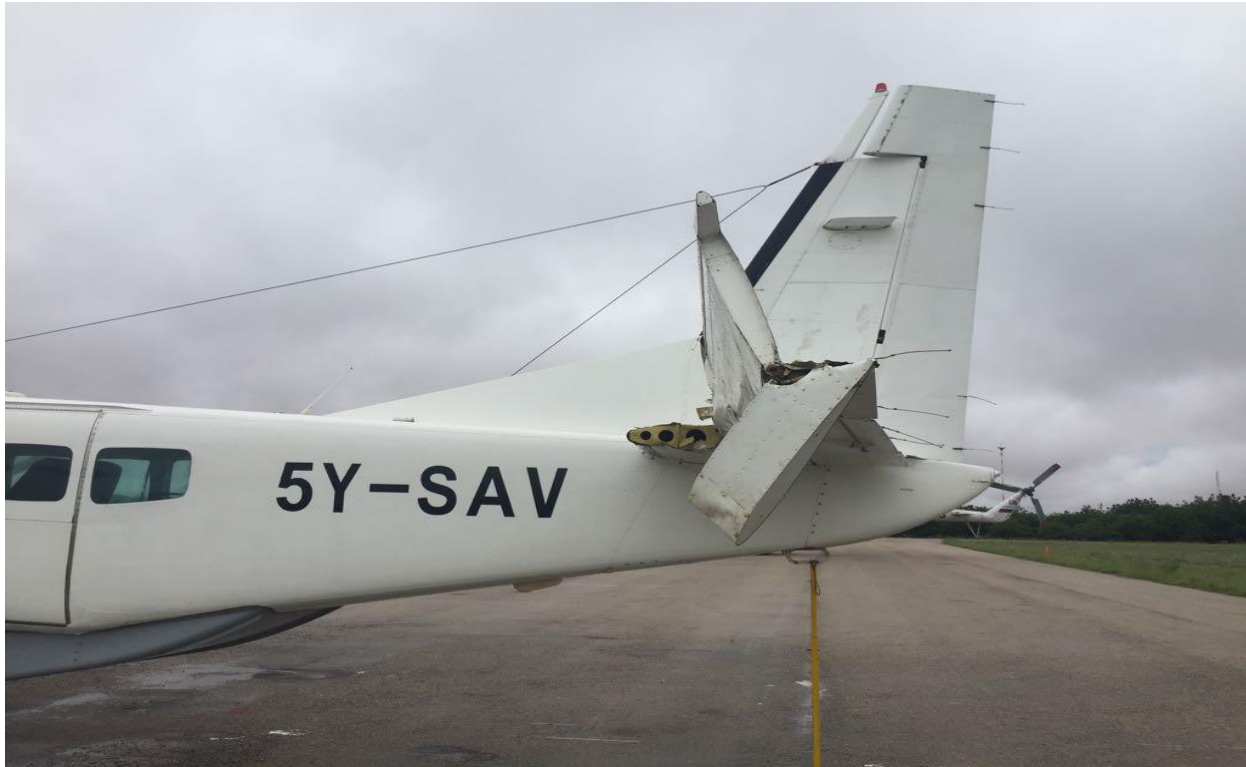
The pilot in command (PIC) had departed from Mogadishu earlier in the day on 11 April with fourteen persons on board and landed uneventfully at El Barde. He commenced his take off roll at about 1400 with the point of intended landing as Mogadishu with fourteen persons on board and 450 litres of fuel that translated to about four and half hours endurance. The PIC states that while on the take off roll, a stone apparently impacted the horizontal stabilizer. He proceeded to bring the aircraft to a stop, shut down the engine and disembark the passengers.

Based on his own assessment of the damage, he elected to fly the aircraft to what he considered the nearest safest place the next morning. He departed El Barde at 0325 on the 12 April and landed in Wajir airport at 0515. He states that upon landing, he inspected the aircraft and realized the damage had become more pronounced. He then contacted the Approved Maintenance Organization (AMO) which was in charge of the aircrafts maintenance. The AMO advised that the aircraft not be flown further but remain at Wajir awaiting necessary maintenance actions to be performed.
