AIR ACCIDENT INVESTIGATION

Factual Accident Report on

NYNJA MICROLIGHT

Registration F-JSCZ

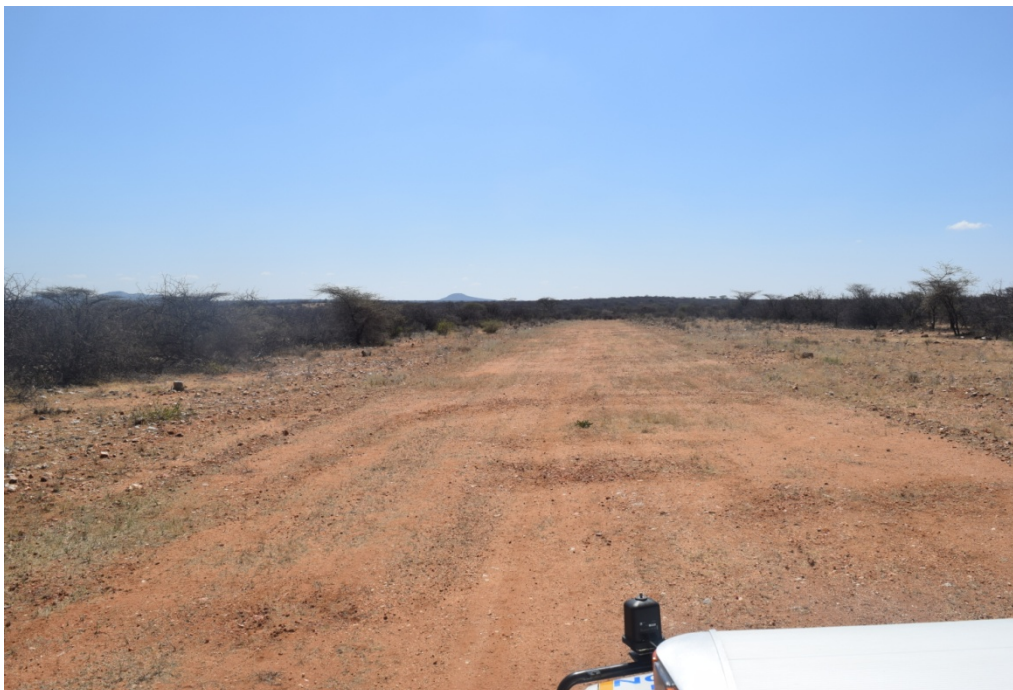
Fig 1: Take Off Runway 09 (700 meters long)

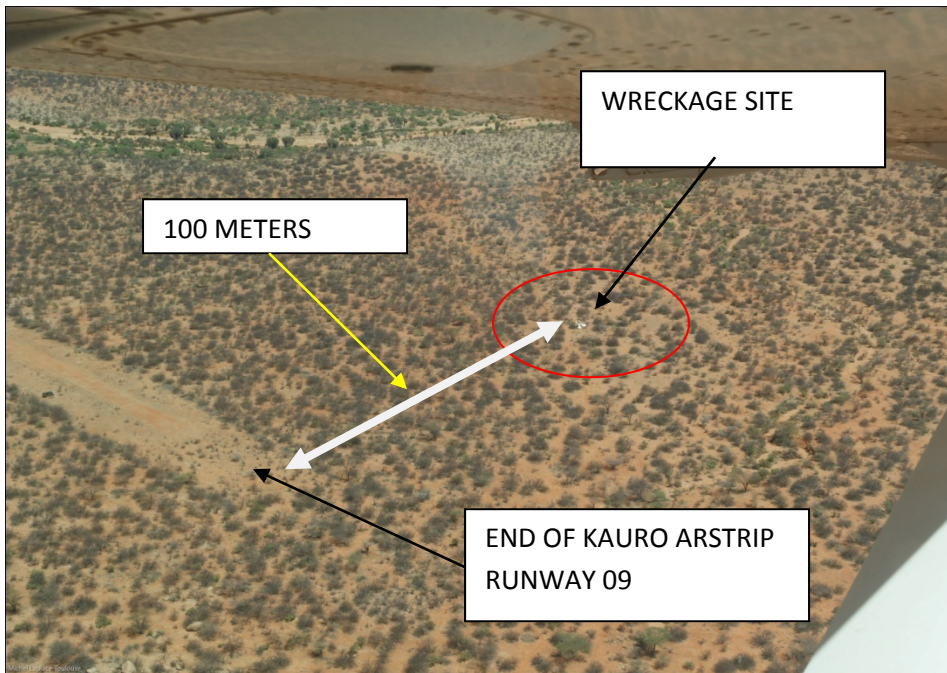
At 0800 the pilot made a normal take off on runway 09 heading. As he turned crosswind for a left hand circuit the aircraft crashed 100meters from the airstrip in a scattered bush. The micro light crashed in a nose low attitude and both occupants were fatally injured. The aircraft was destroyed

FIG 2: AERIAL VIEW OF WRECKAGE SITE

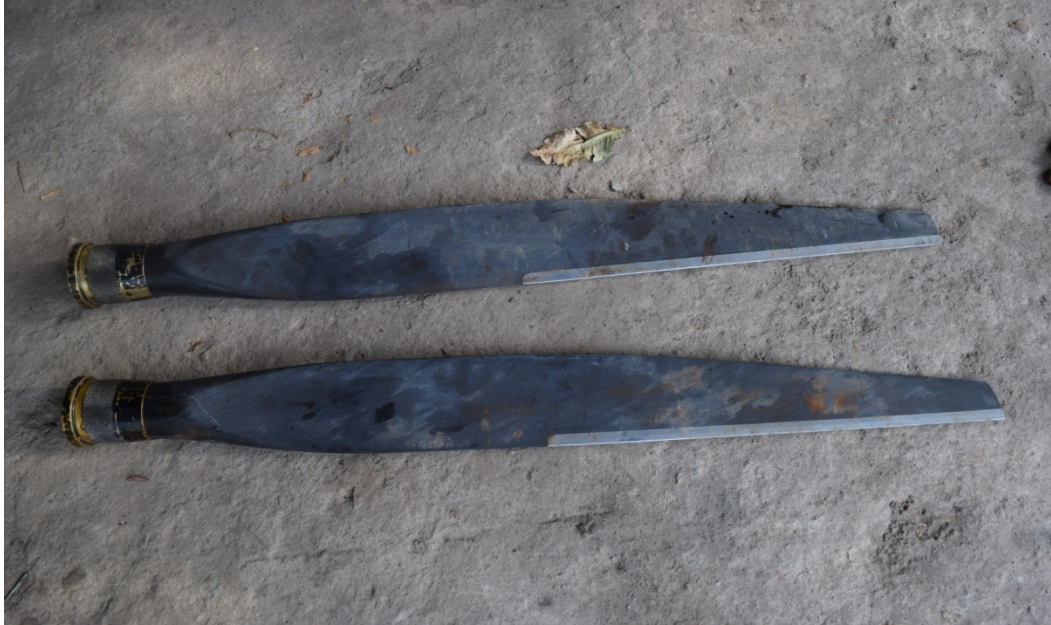
The propellers remained intact and attached to the hub, with no signs of twisted cord.

Fig 2: Propeller Blades showing normal condition

One of the blades was bent inwards after the impact with the ground. It did not indicate factors of a rotating blade. The other two blades were intact and appeared to be in a normal state. The gearbox separated from the engine block due to impact.

- The blades condition were consistent with the theory of engine not producing power to turn the propeller
- The gear train connecting the propeller hub and the gear box broke on impact

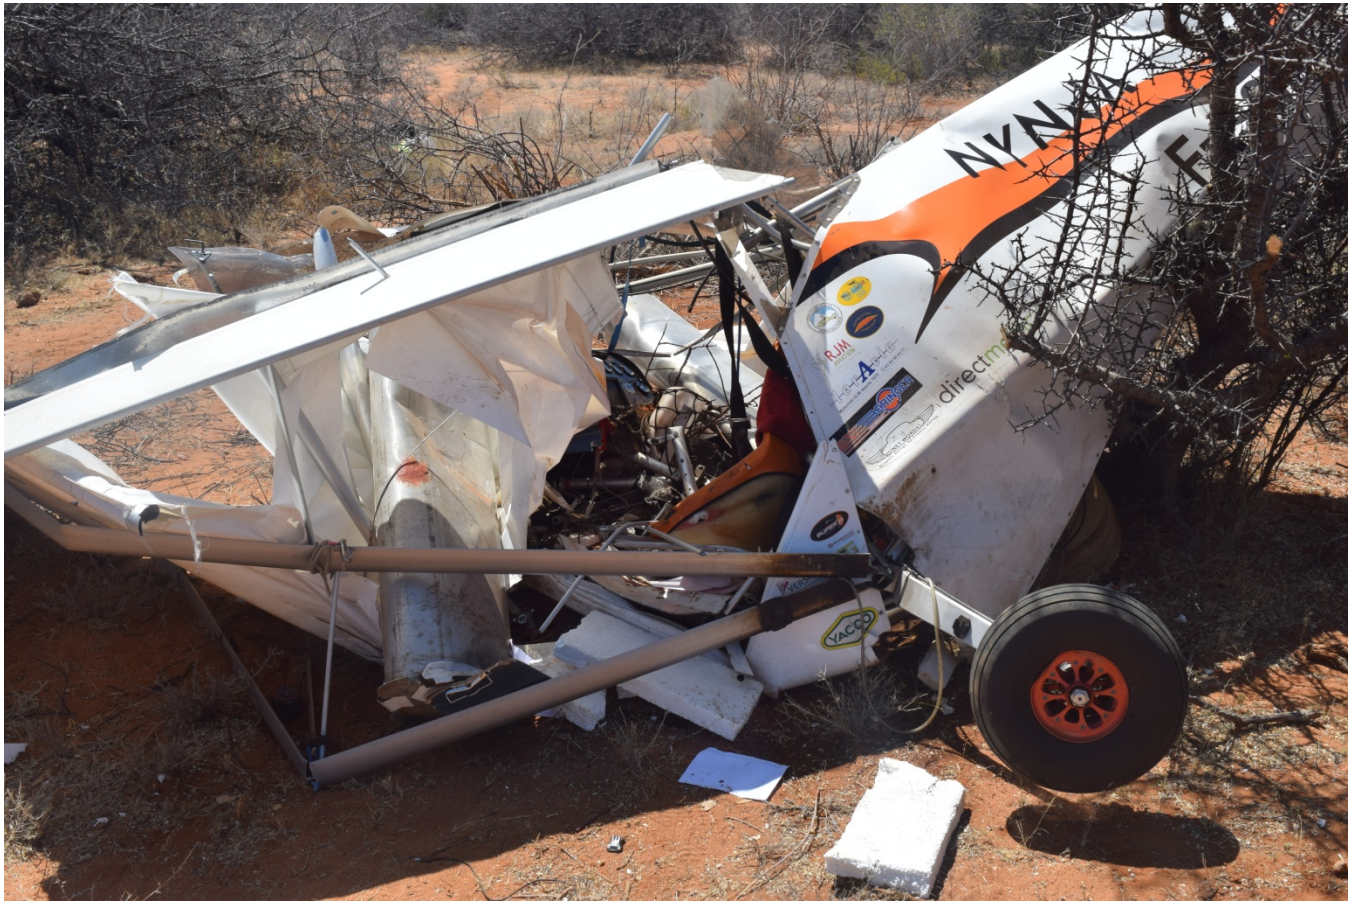
The aircraft was destroyed on impacting the ground in a nose down attitude, with only one impact mark. The cockpit and the engine were mangled. The fuselage was extensively damaged and was crumpled together with the cockpit and the engine.. The impact broke the gear train connecting the engine and the propellers. The aircraft plummeted into the air and made a 180° turn before settling on the ground facing the direction it had come from.

Fig 3: Damaged Wreckage

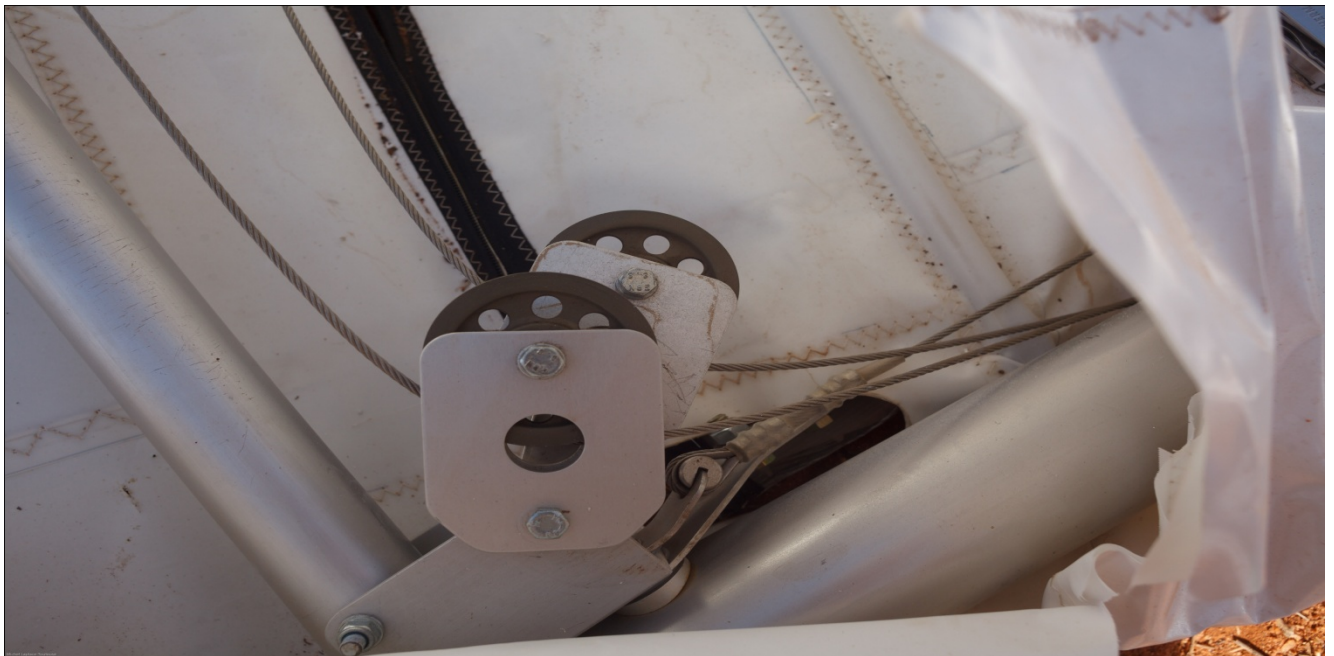
The amount of bush that was disturbed by the crash was very minimal. The few pieces of glass and broken fuselage were within the aircraft span area. The control linkages were in position with a few having been broken after the impact.

Fig. 4: Right Aileron Linkages in Place

- Both left and right aileron control cables were in position when the wreckage was inspected.
-
- The AAID found that during the turn just after taking off, the aeroplane's engine ceased operating. The aeroplane's airspeed before the engine failure was marginally above the estimated stall speed during the high-bank turn. After the engine failure, it is likely the aeroplane entered an aerodynamic stall. The associated loss of control was not recovered and the aircraft collided with terrain

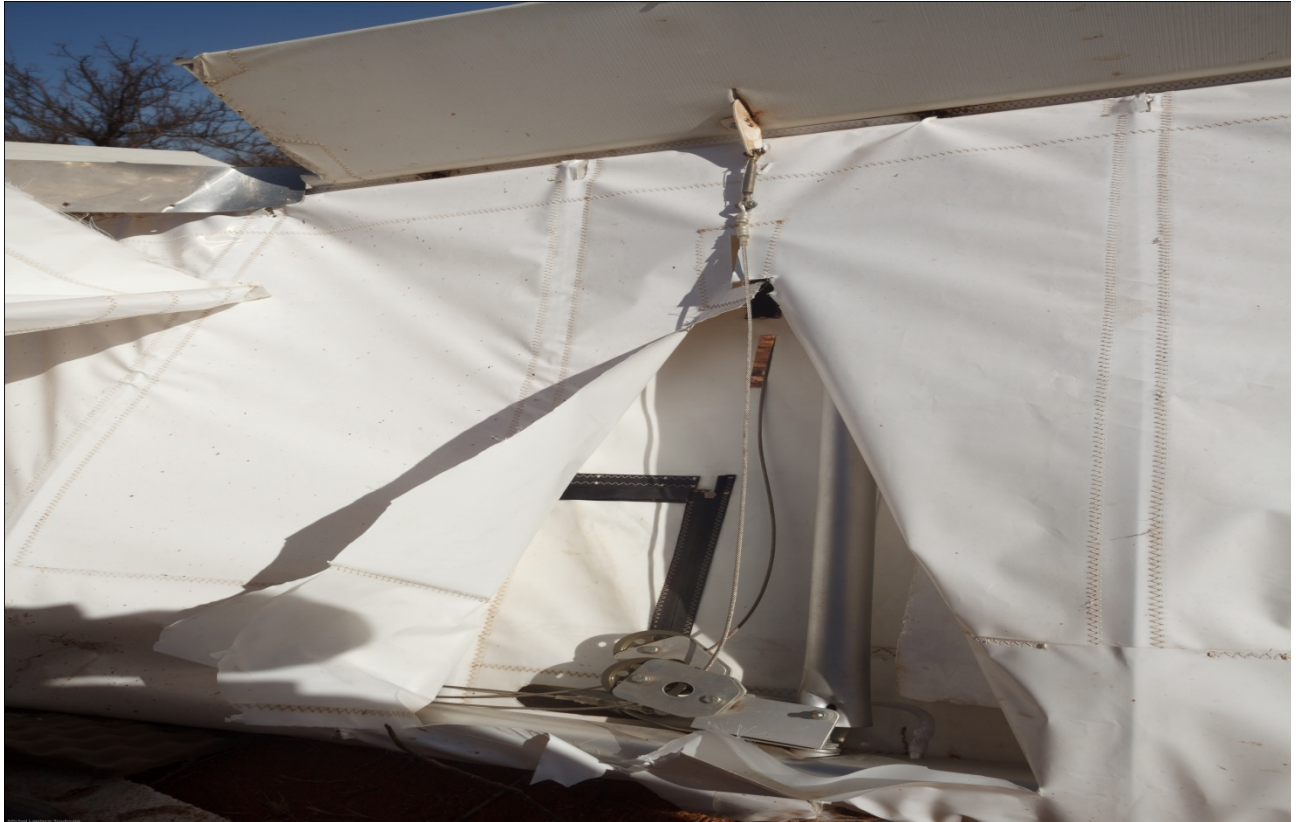
Figure 5: Left Aileron Linkage

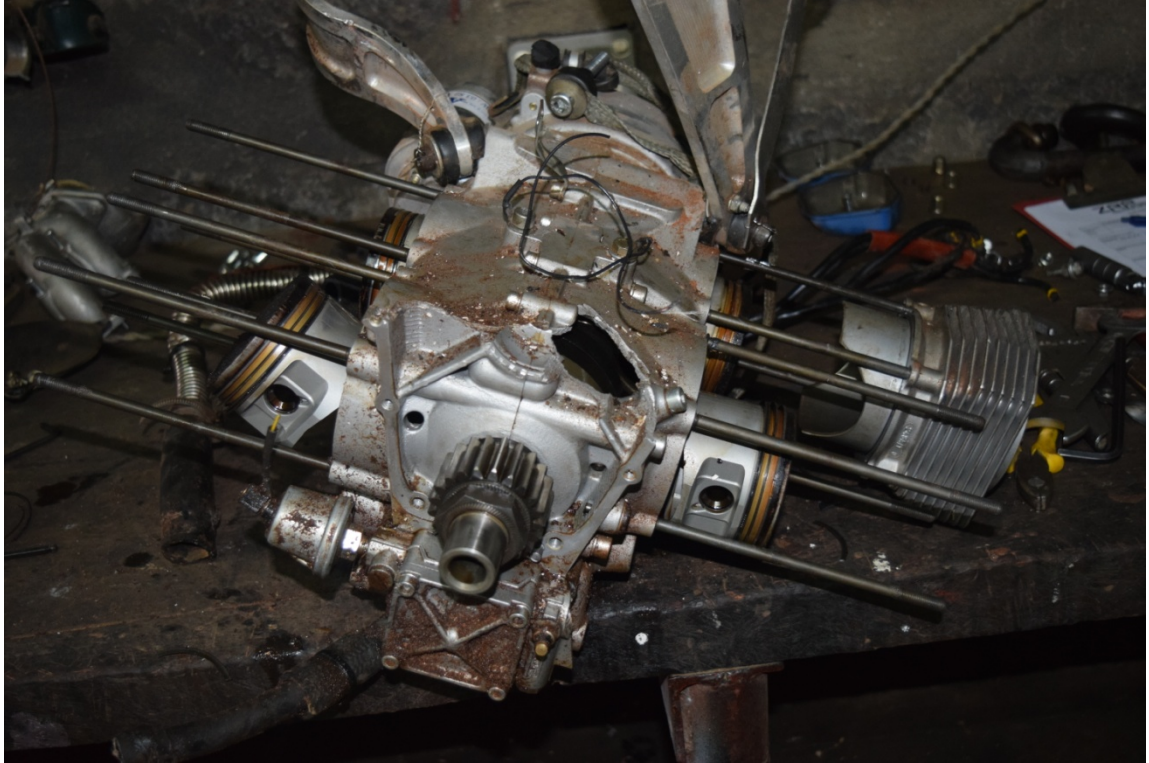
The engine block surface over No 3 piston had a large non symmetrical hole. The crank shaft was not removed nor inspected. It was difficult to make a complete revolution of the crank shaft.

Fig 6: Surface of the Engine block showing a large hole

The nature of occurrence is associated with aircraft stall, controls failure or engine loss of power. After examination of the engine it is possible that there was a piece of a rotating organ that broke loose within the engine block. The suspected foreign object punctured the engine block and forced a sudden ceasure of the crank shaft. There was no evidence of oil spillage in a pool at the scene. There was evidence however of oil splash on the engine at the scene.

The hole in the engine block is a possible damage from a piece of metal broken from inside the engine. The hole made by the foreign object inside the engine block led to engine oil spillage and subsequent engine ceasure.
