**MINISTRY OF ROADS AND TRANSPORT  
STATE DEPARTMENT FOR TRANSPORT  
AIRCRAFT ACCIDENT INVESTIGATION DEPARTMENT**

**INVESTIGATION REPORT 01/03/2024 - Rev 1**

**PRELIMINARY INVESTIGATION REPORT ON THE MIDAIR  
COLLISION ACCIDENT INVOLVING CESSNA C172M AIRCRAFT  
REGISTRATION 5Y-NNJ AND BOMBARDIER DE HAVILLAND  
DASH 8 DHC 8-315 AIRCRAFT REGISTRATION 5Y-SLK, ON  
05MARCH 2024 AT THE NAIROBI NATIONAL PARK, NAIROBI  
COUNTY**

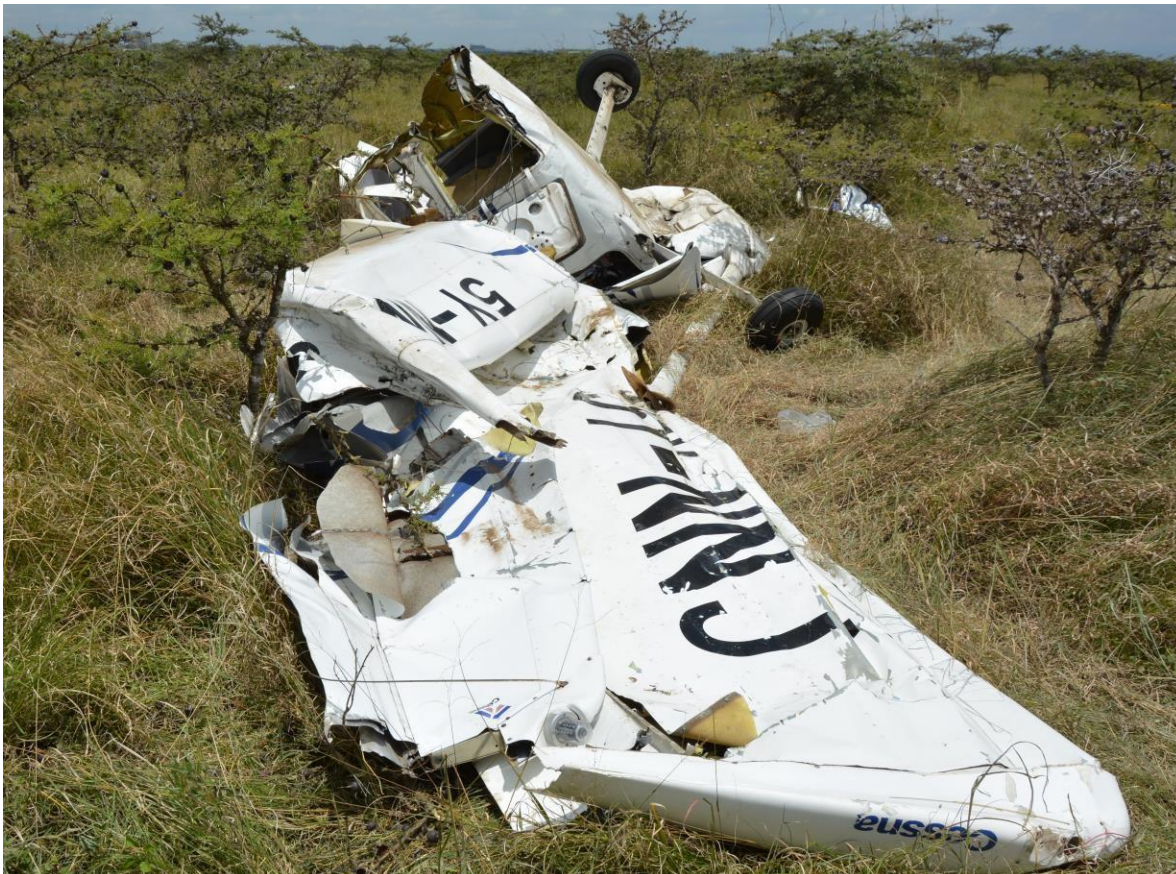
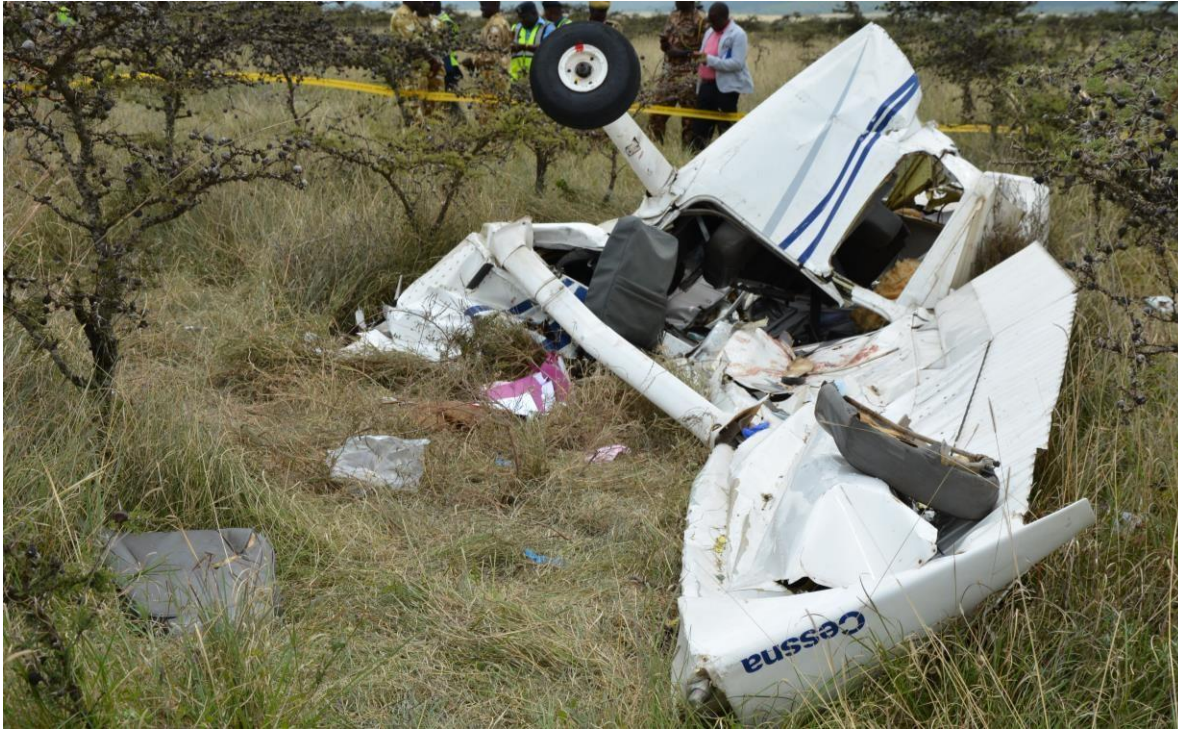
*FIGURE No. 2 and 3 – Photos of the accident site of 5Y-NNJ*

The aircraft was destroyed on coming into contact with the Bombardier De Havilland Dash 8 DHC 8- 315 aircraft and on impact with terrain. The fuselage broke into several sections with the front section, wing, nose and main landing gear, and part of the empennage (vertical stabilizer and rudder) remaining localised in one area. The rest of the empennage (right and left horizontal stabilizer, elevator and trim tab) rested at various locations near the main wreckage.

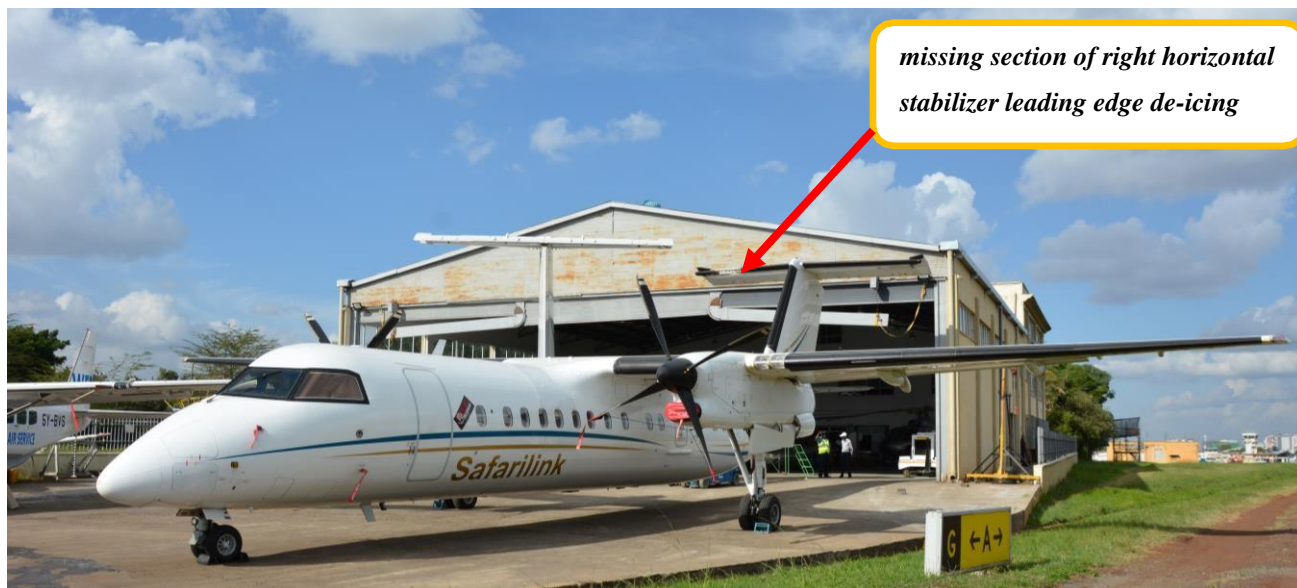
**FIGURE No. 4 – A photo of 5Y-SLK parked outside the operator’s hangar after the midair collision accident**

5Y-SLK landed at HKNW at 0637 (0937). There was no further incident and once the aircraft was parked, all on board disembarked. Upon inspection, it was found that part of the right horizontal stabilizer leading edge de-icing boot was missing. There was no other damage to the aircraft.

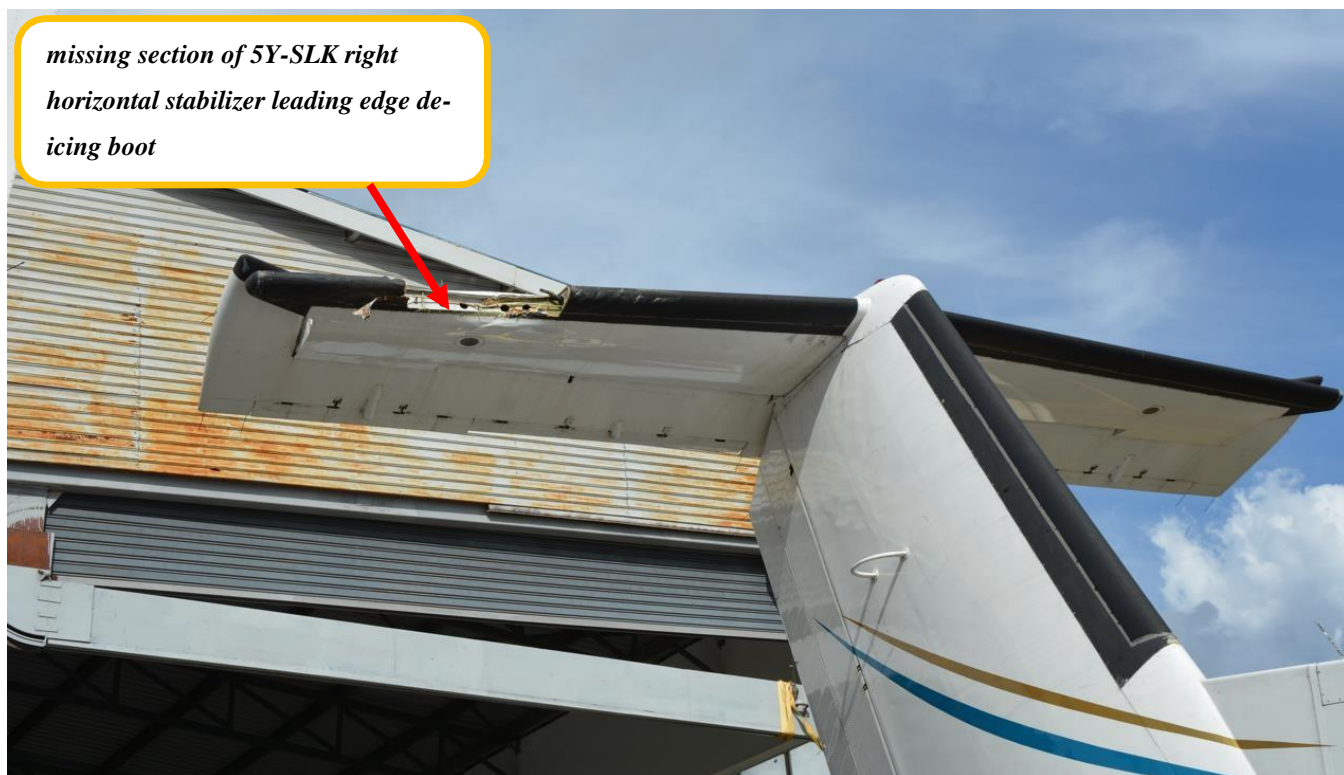
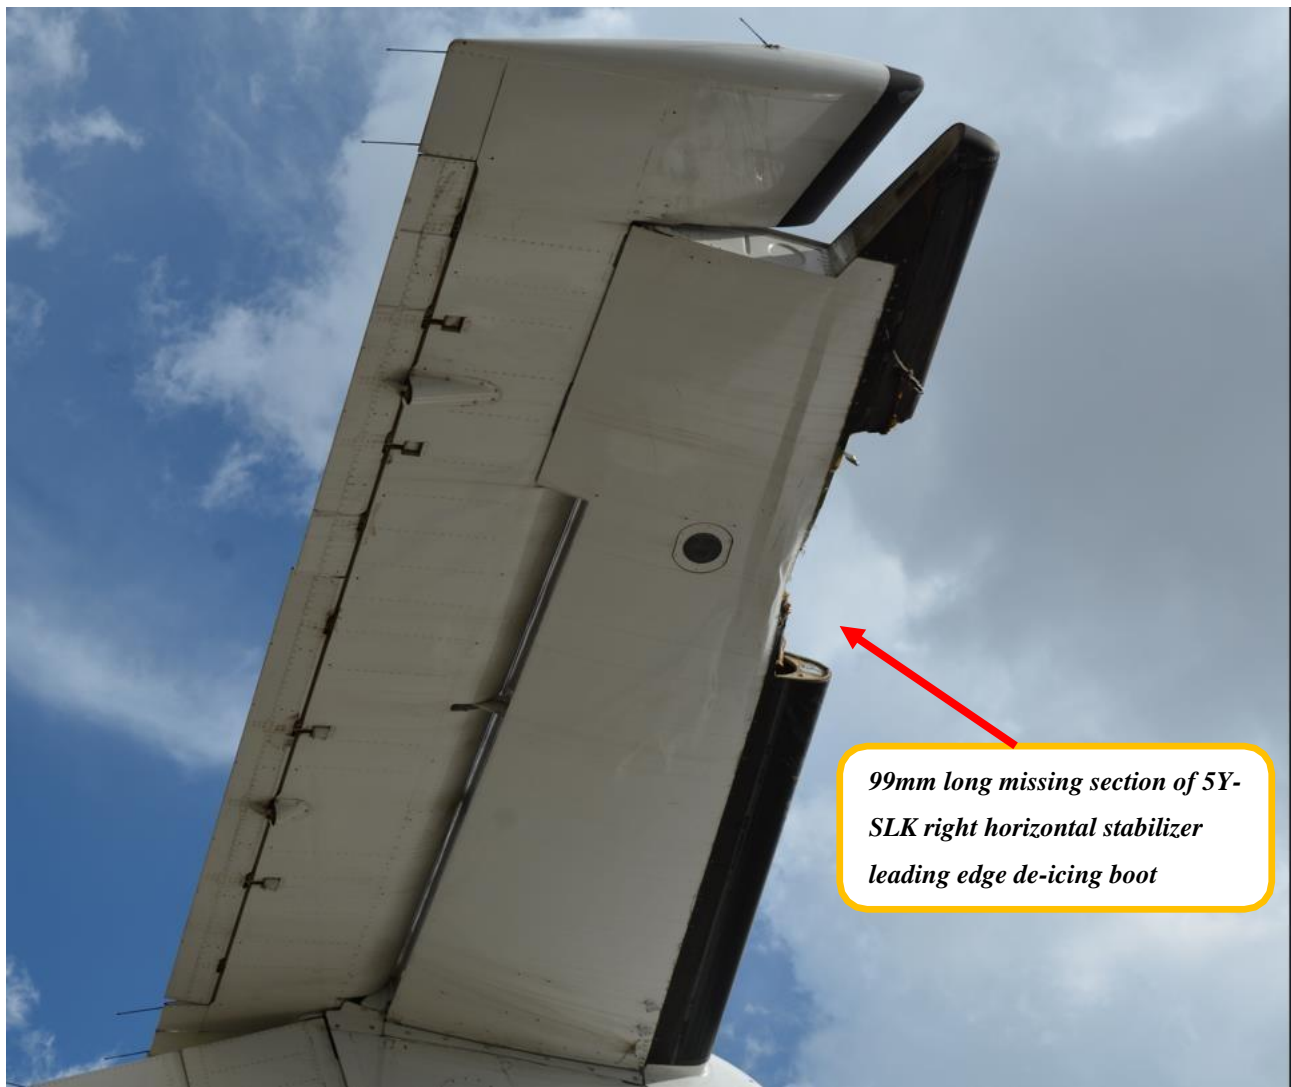
***FIGURES No. 5 and 6 – Photos of the missing section of right horizontal stabilizer leading edge de-icing boot***

The aircraft sustained minor damage to the right horizontal stabilizer de-icing boot. The missing right outboard horizontal stabilizer leading edge de-icing boot was found at the accident site near the main wreckage of 5Y-NNJ.

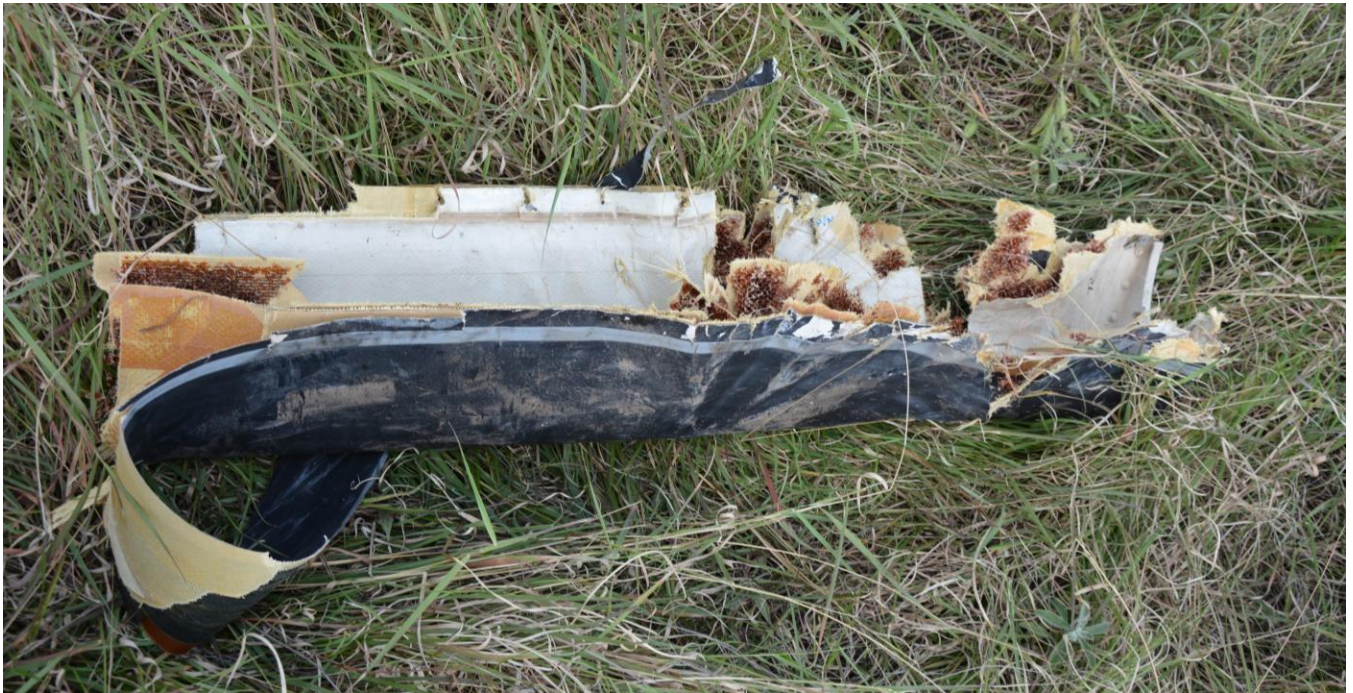
*FIGURE No. 7- A photo of the right outboard horizontal stabilizer leading edge de-icing boot at the 5Y-NNJ crash site*

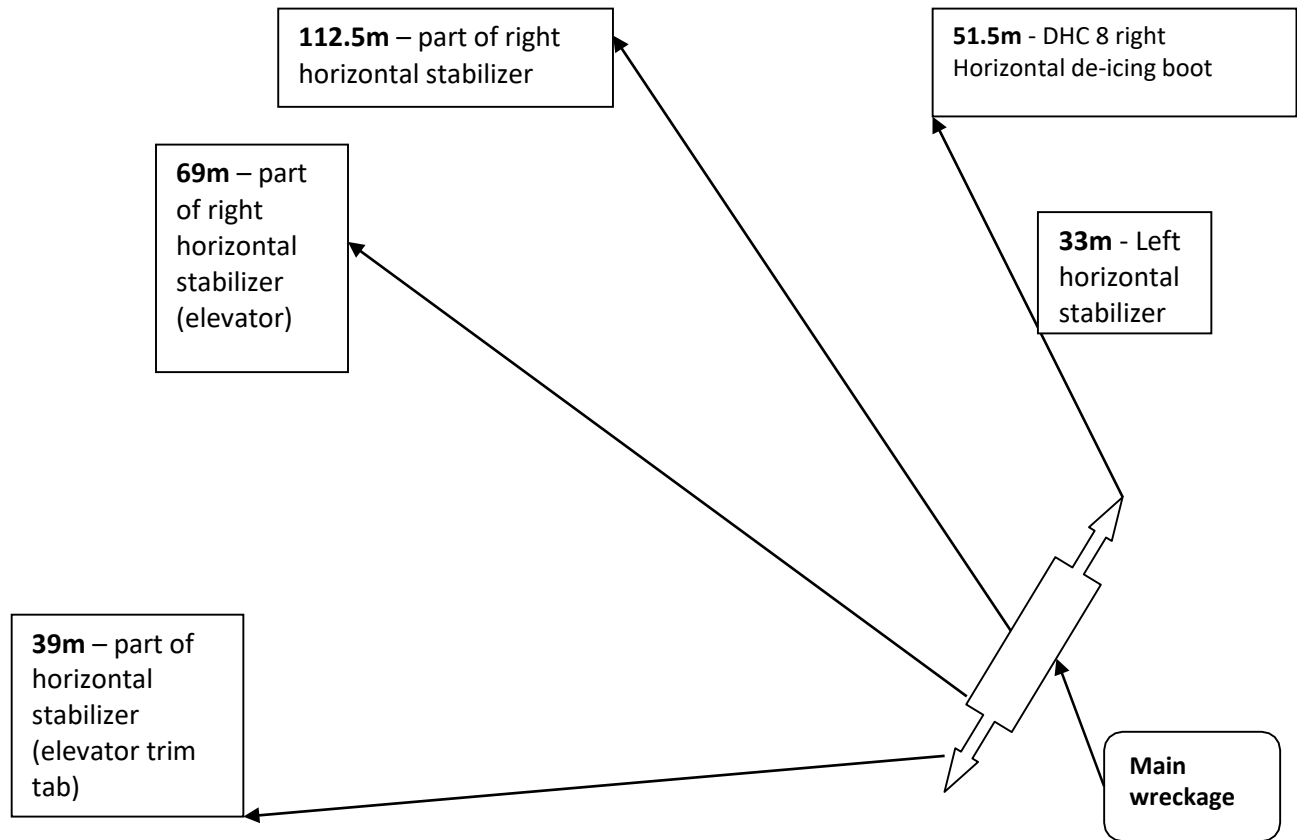
**FIGURE No. 12 – A general sketch of the 5Y-NNJ accident site wreckage distribution and distance from the main wreckage to other parts – not to scale**

The accident site of 5Y-NNJ was about 1.663 NM inside the Nairobi National Park to the right side of extended centreline of RWY 14 (upwind), coordinates 1° 20' 32" S, 36° 50' 01" E. The horizontal stabilizer of 5Y-NNJ broke midair into several pieces when the aircraft came into contact with 5Y-SLK's right horizontal stabilizer leading edge de-icing boot. The parts fell at a distance from the main wreckage. The initial midair collision point of 5Y-NNJ was the lower empennage (tail plane) severing the horizontal stabilizer that fell first at different locations along the flight path and in three pieces comprising part of the left horizontal stabilizer and the elevator, part of the left stabilizer, and part of the left elevator and elevator trim tab. 5Y-SLK 99mm width right horizontal stabilizer leading edge de-icing boot was found 18.5m away from the left horizontal stabilizer of 5Y-NNJ. The main wreckage was found to be the last along the flight path and it broke into several sections with the front section, wing, nose and main landing gear, and part of the empennage (vertical stabilizer and rudder) remaining localised in one area. The engine and propeller were covered under the nose wheel assembly. The cockpit and various indicators were destroyed. Fuel tanks ruptured and there was evidence of fuel saturation on the ground.

5Y-NNJ was found to have also been destroyed by deceleration forces as it impacted the levelled terrain in a high angle. Part of the tail plane separated from the main fuselage and curved upwards 40° at 130m aft of the baggage area (reference station 108.00).

Onsite investigation observed that the midair collision occurred when the tail section of 5Y-NNJ came into contact with the 5Y-SLK's right horizontal stabilizer leading edge de-icing boot. The aircraft, having spiralled to the ground, was found facing the opposite direction to the flight path.
