AIRCRAFT ACCIDENT INVESTIGATION

REPORT OF GYROPLANE
REGISTRATION 5Y-KWV
NEAR ORLY AIRPARK
ON 19TH NOVEMBER 2020

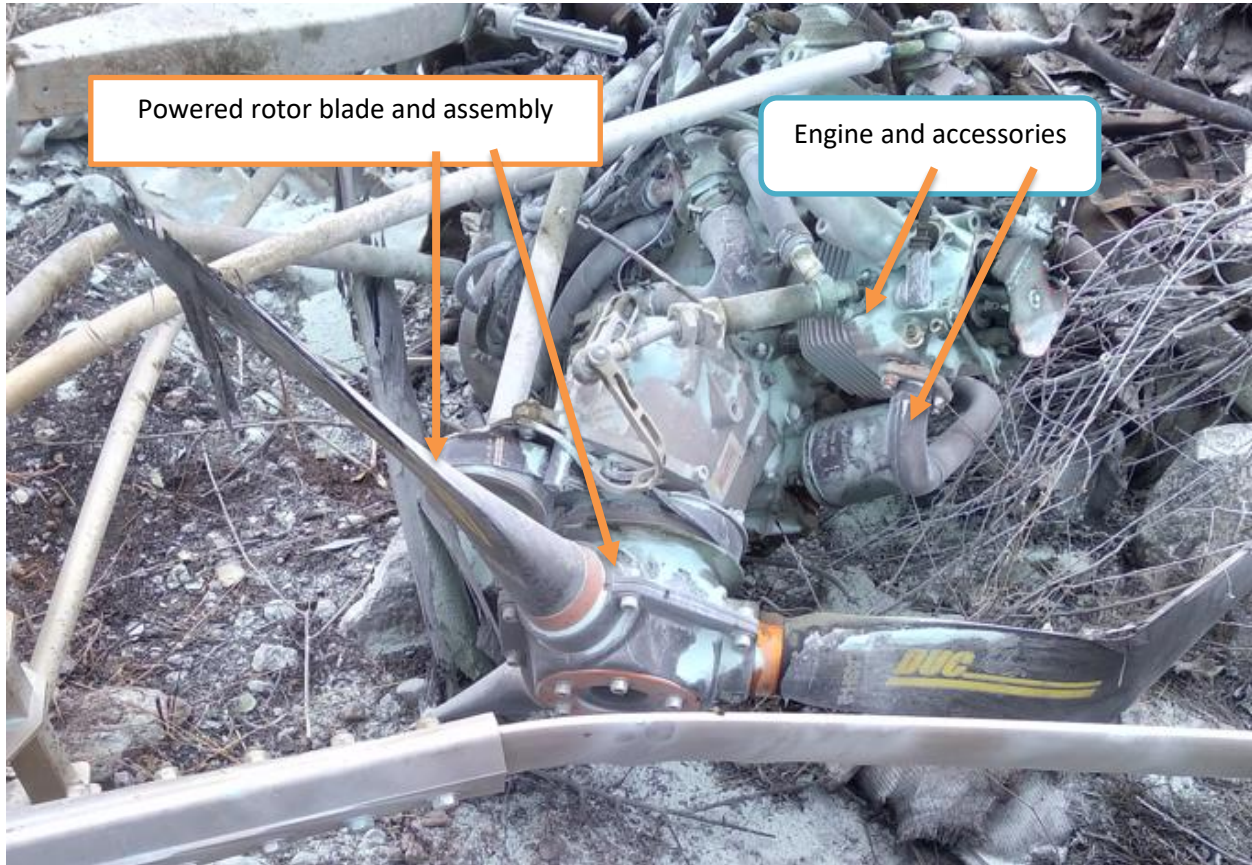
broken and separated as the other section remained still attached to the assembly but got several dents. All the undercarriage got broken and burnt completely. Propeller on the powered-rotor got broken and burnt but was found attached to the engine.

Figure 3: Photograph showing wreckage of the Gyroplane engine and accessories

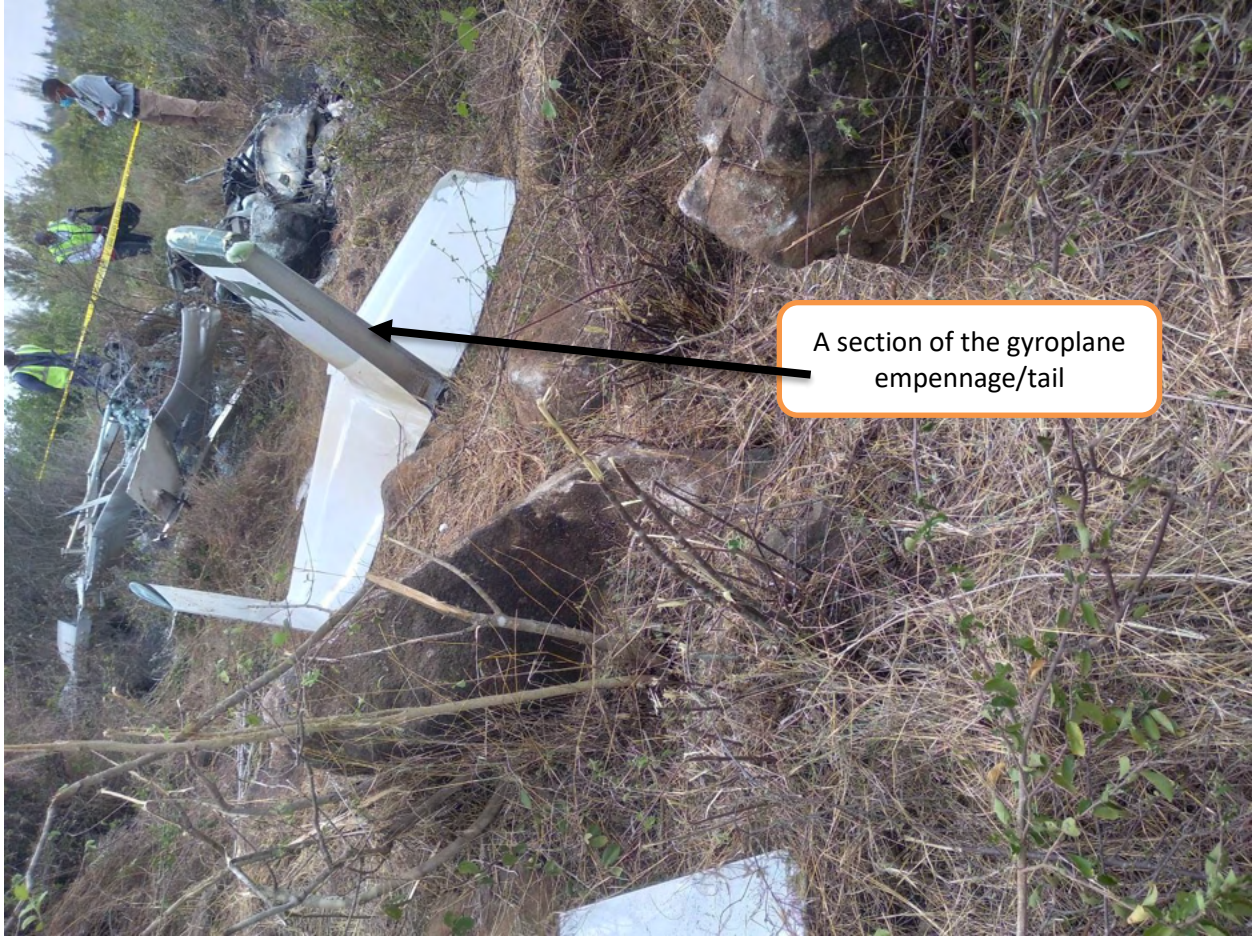
A section of the gyroplane empennage/tail

Figure 4: Photograph showing the Gyroplane empennage

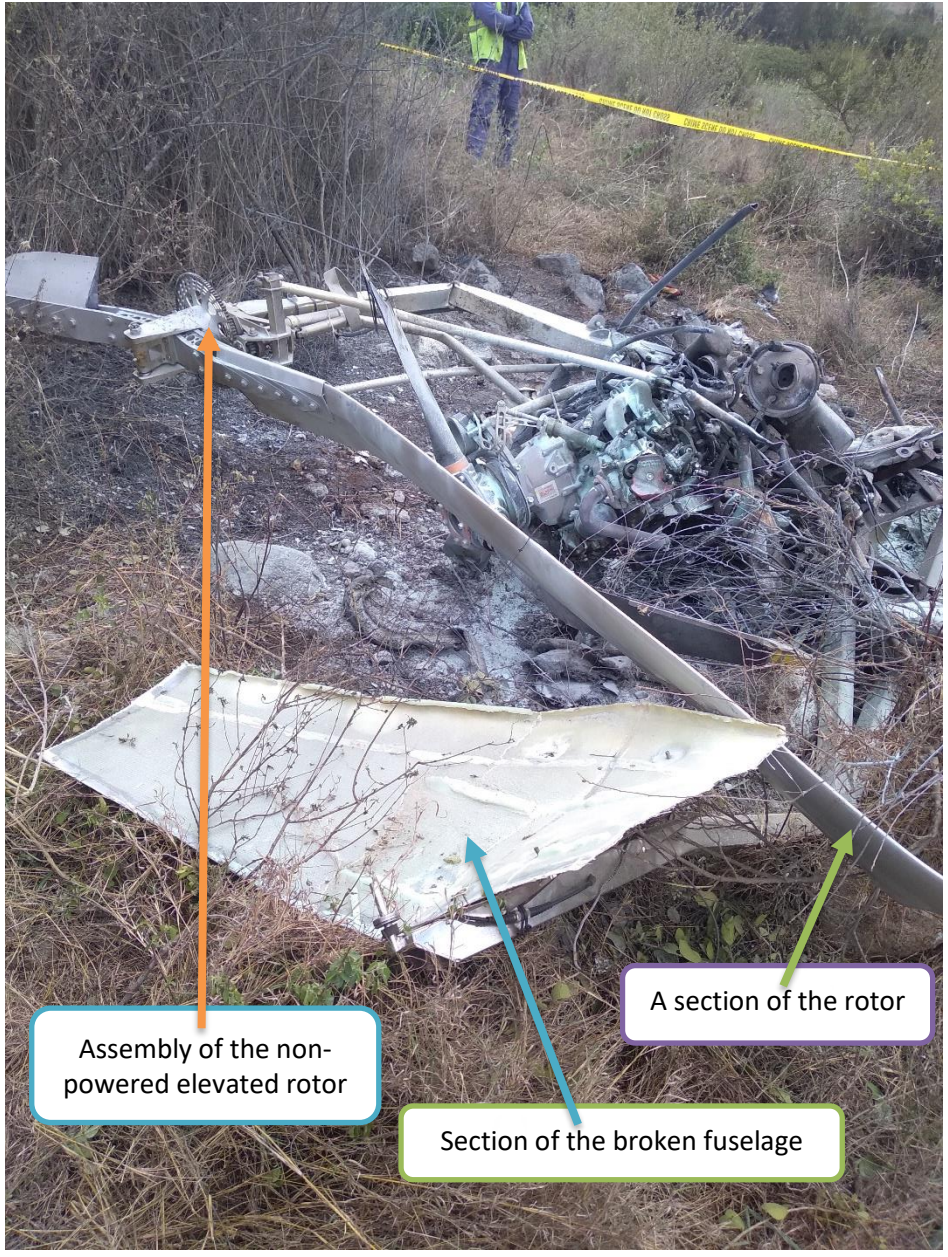
Most parts of the gyroplane got broken and burnt after impact. The wreckage of the gyroplane was confined within a small area of 10m radius after impact. One blade of the non-powered rotor got

Figure 5: Photograph showing the non-powered rotor of the Gyroplane

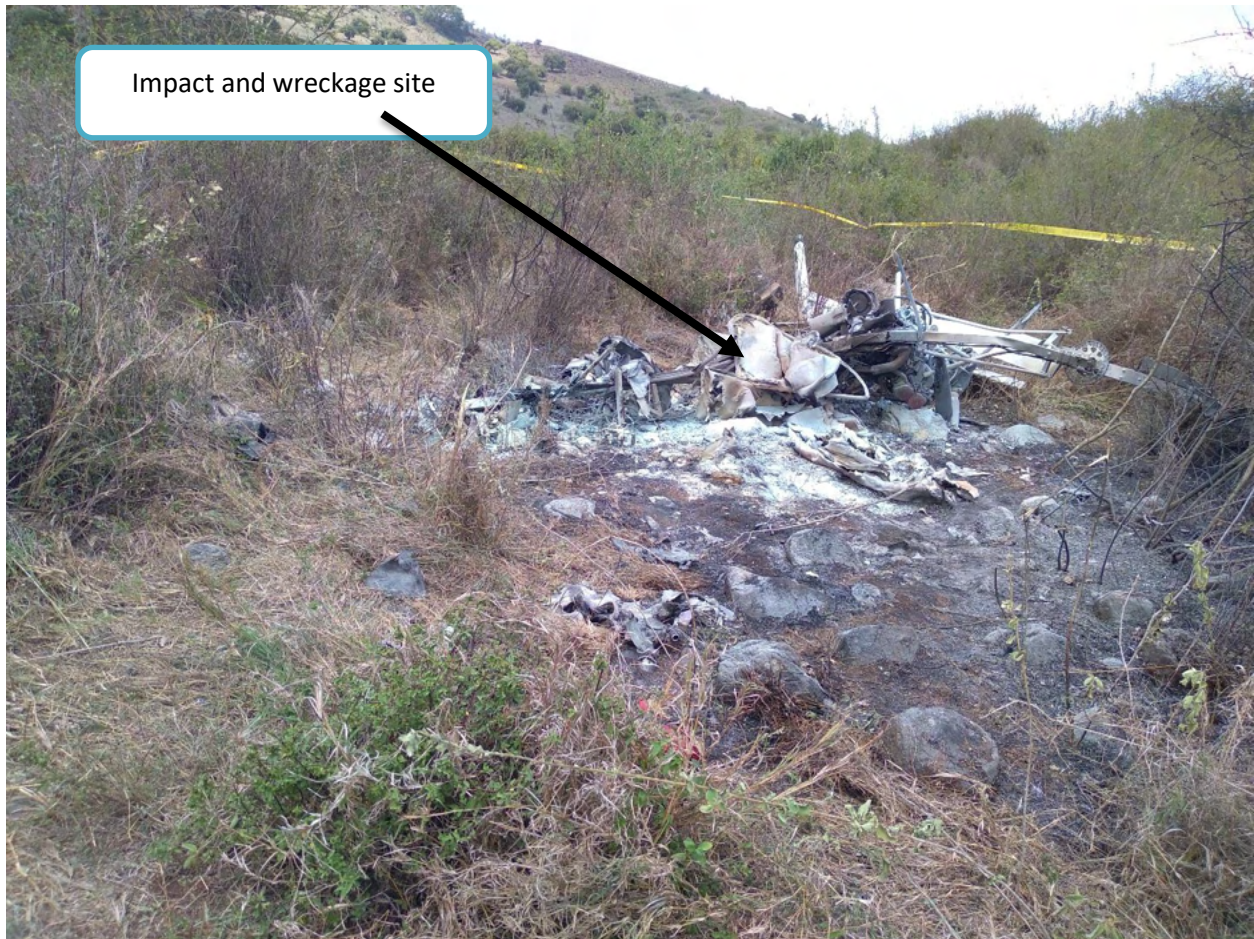
Figure 6: Photograph showing the accident site of the Gyroplane

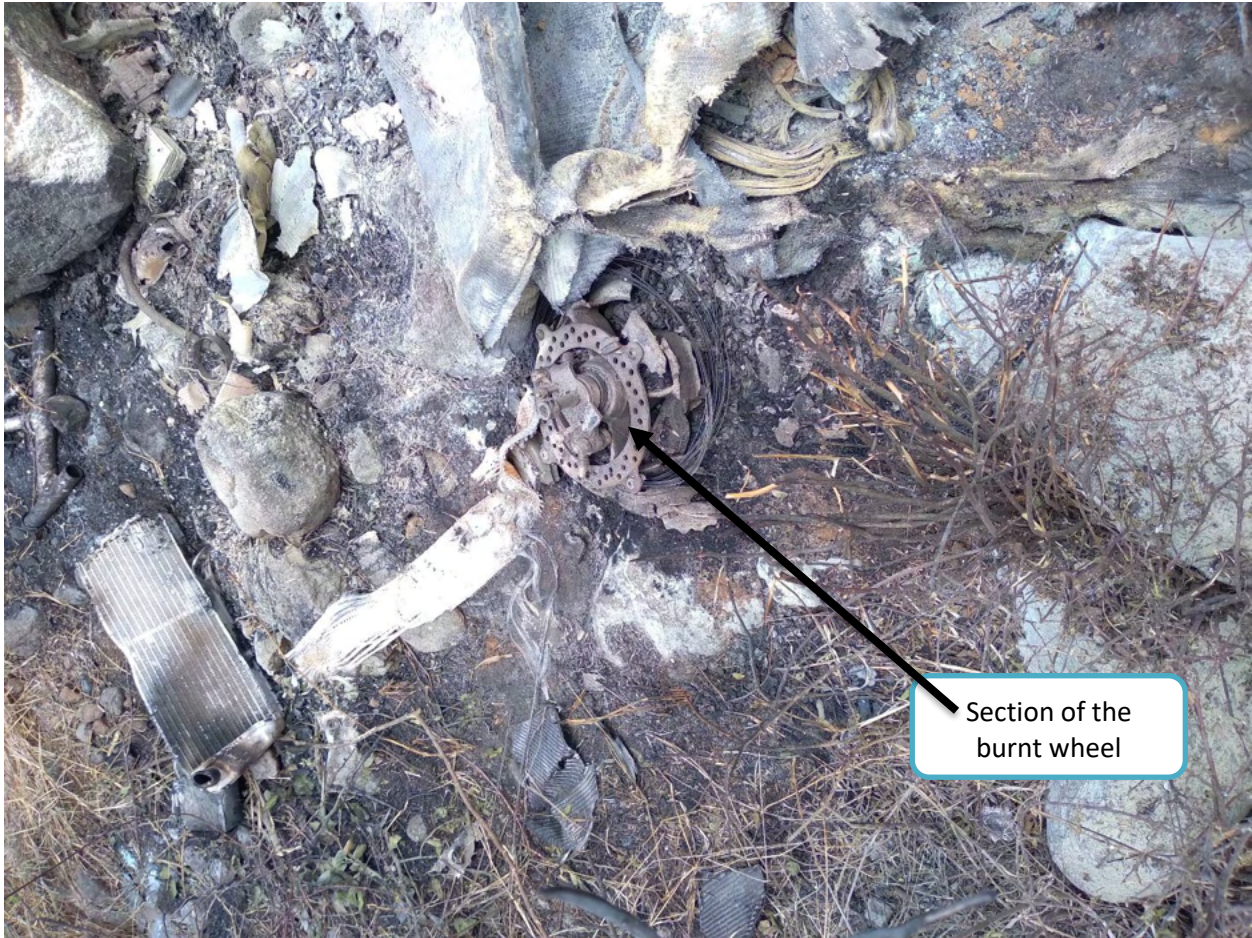
Figure 7: Photograph showing the wreckage of the burnt Gyroplane wheel assembly.
