AIRCRAFT ACCIDENT INVESTIGATION DEPARTMENT

PRELIMINARY INVESTIGATION REPORT 25/09/22

SERIOUS INCIDENT INVOLVING A FOKKER 27 MK0502

AIRCRAFT REGISTRATION 5Y-FAI

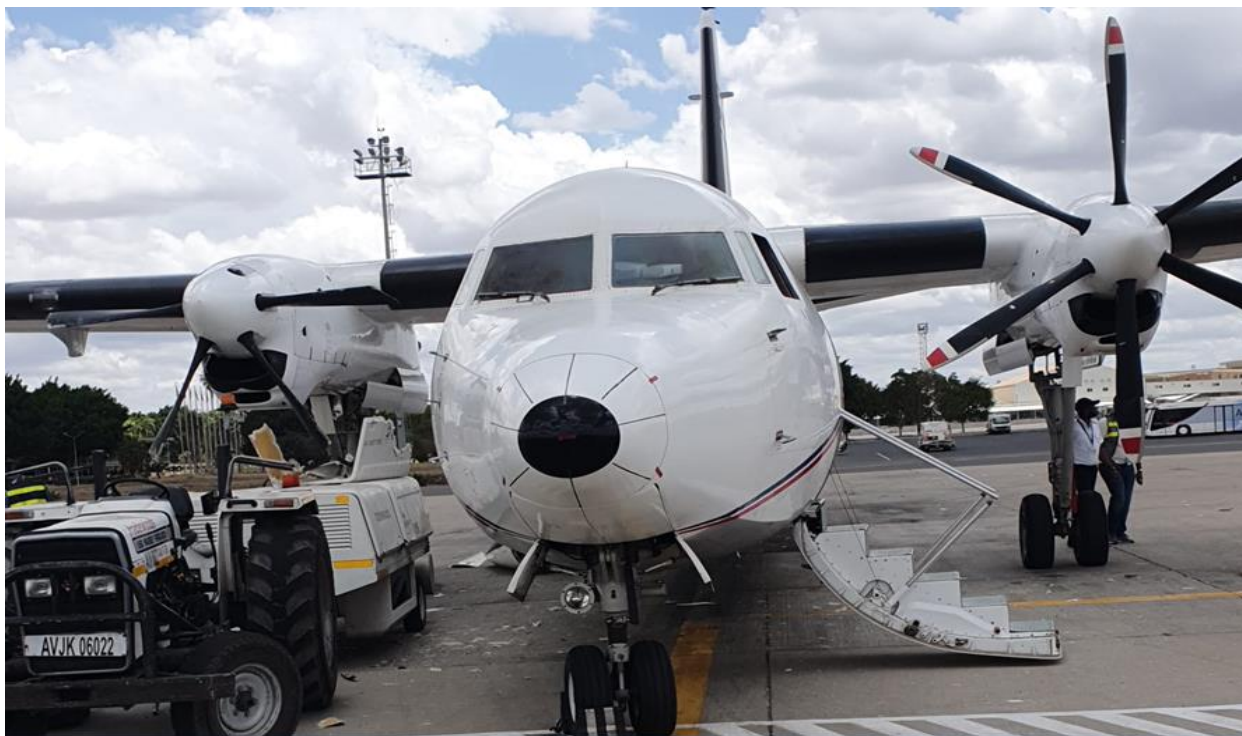
Figure 1: The aircraft viewed from the front after the occurrence.

The 2 propeller blades on engine no.2 separated from their attachment at the root and the other four disintegrated at various lengths after striking the GPU. The top right side of the fuselage suffered abrasion and puncture due to the impact of the shrapnel. The power plant suffered external visual damage.

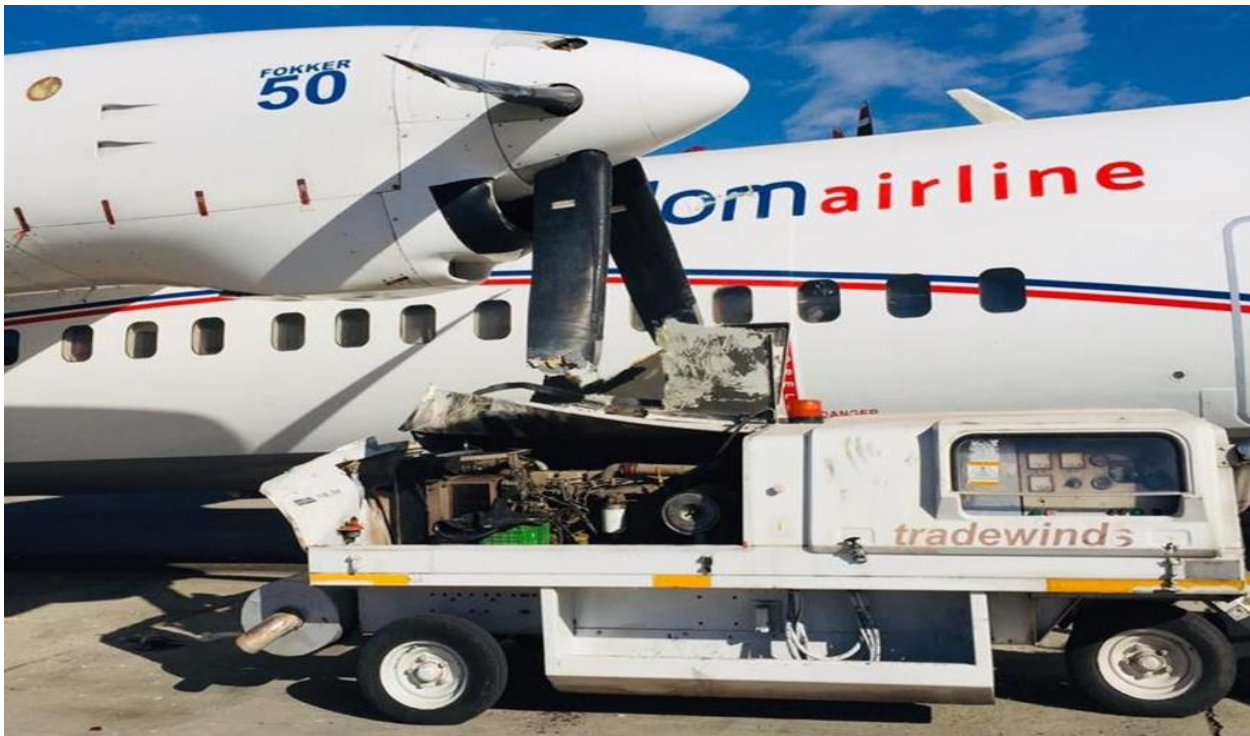
There was damage to the upper part of the rear section of the GPU.

Figure 4: Damage on the GPU

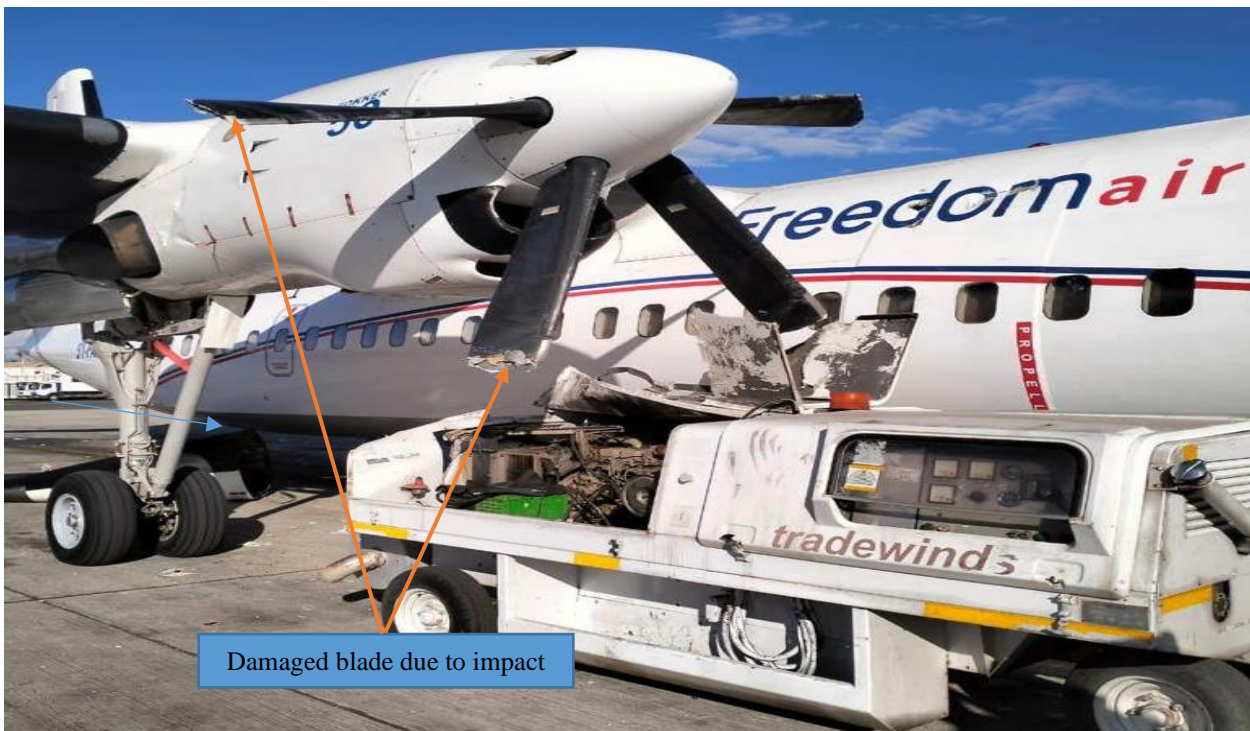
The aircraft structure remained intact except for the damage of 4 R/H propeller blades and the separation of 2 other propeller blades on impacting with the stationary GPU. The GPU sustained substantial damage on impact with the propeller blades. The two separated propeller blades were recovered 140metres from the aircraft with remnants of the propeller blades penetrating the upper forward section of the fuselage above window number 5.

Figure 5: Damage on the R/H propeller blades

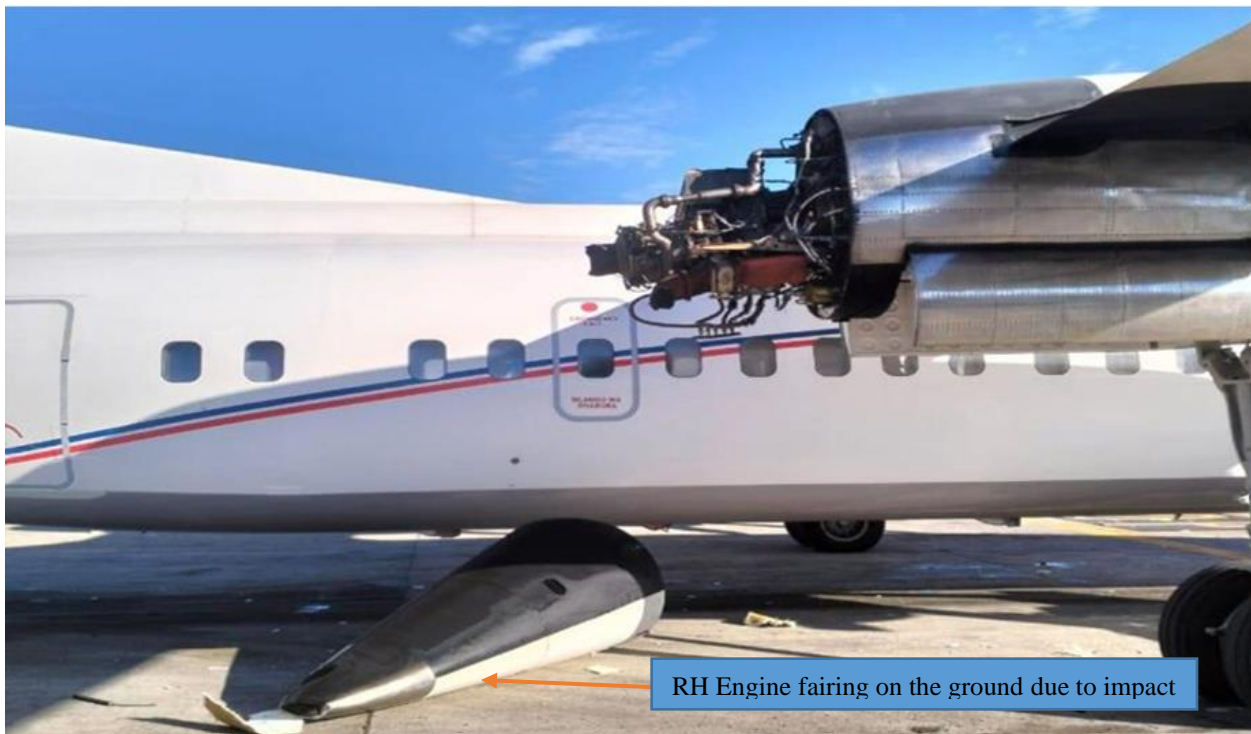
Figure 6: The RH side AFT section

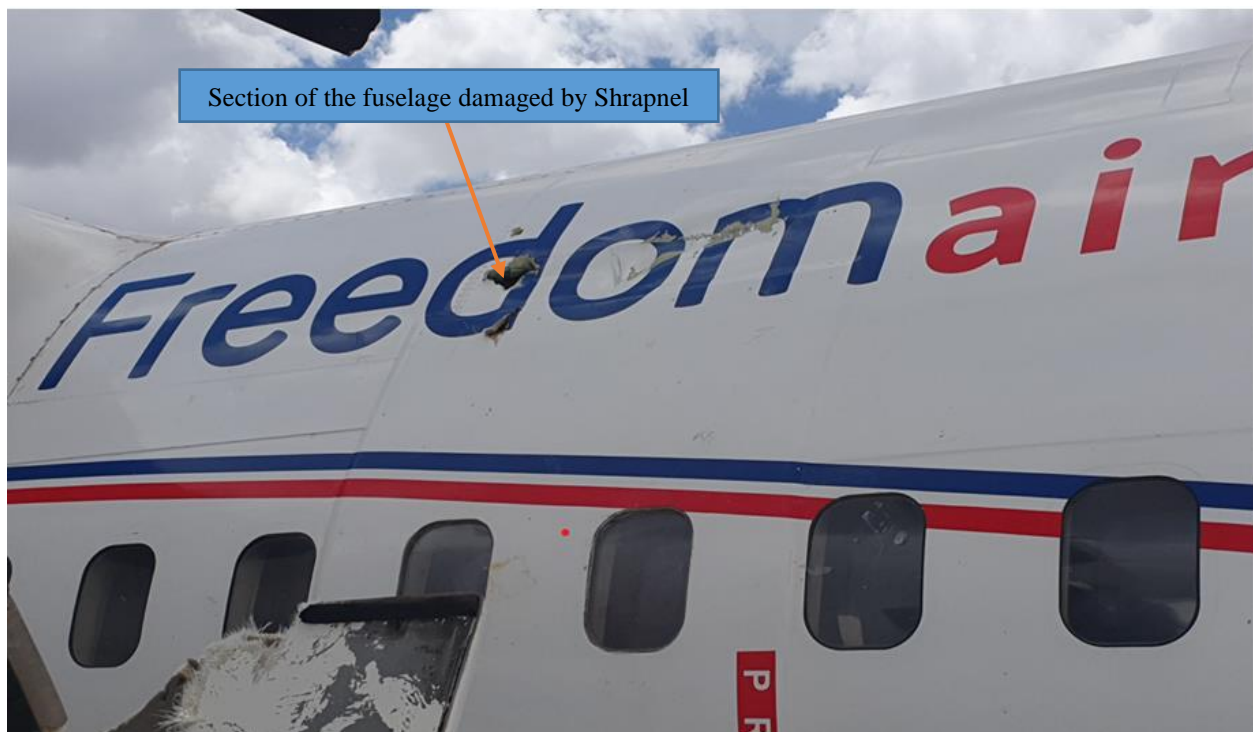
The aircraft sustained substantial damage to its RH Engine and shrapnel penetrated the upper part of the fuselage above the RH window NUMBER 5. The GPU was damaged and no injuries were reported.

Figure 7: Fuselage penetrated by the Shrapnel.

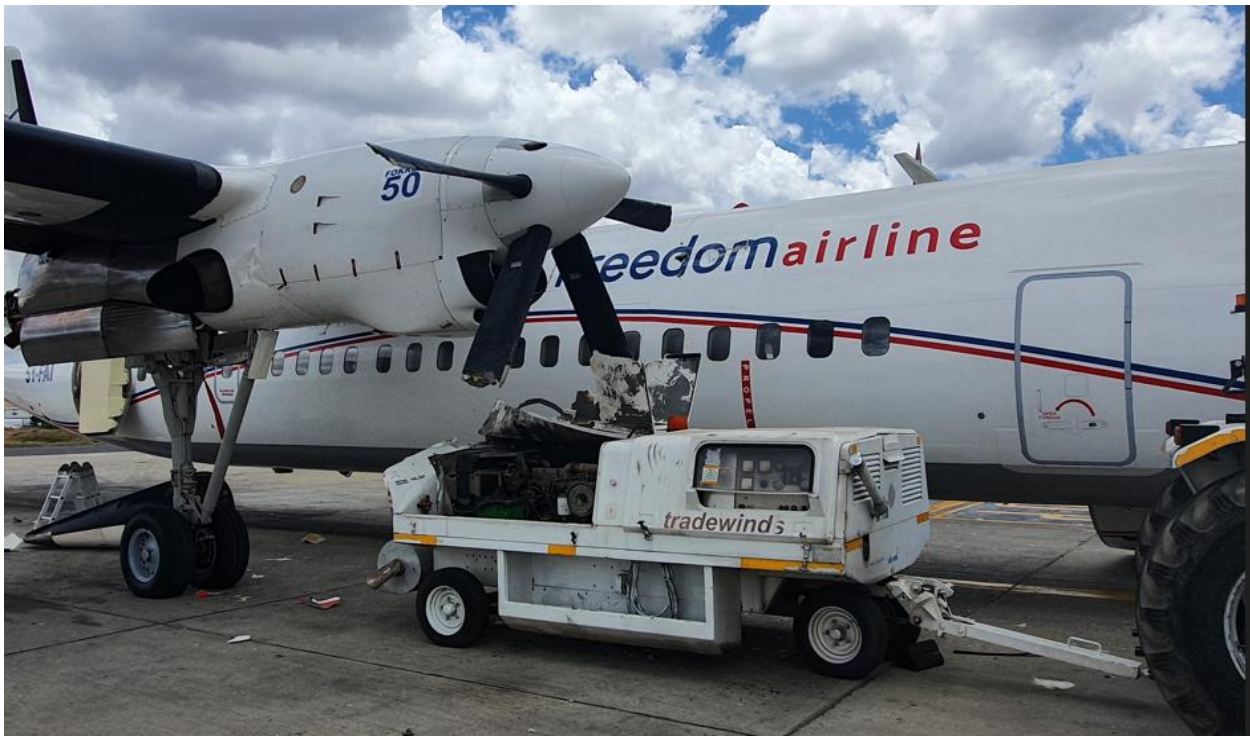
The cause of the incident was the impact between the R/H propeller blades and the Ground Power Unit.

Figure 8: Damaged propeller blades and the GPU

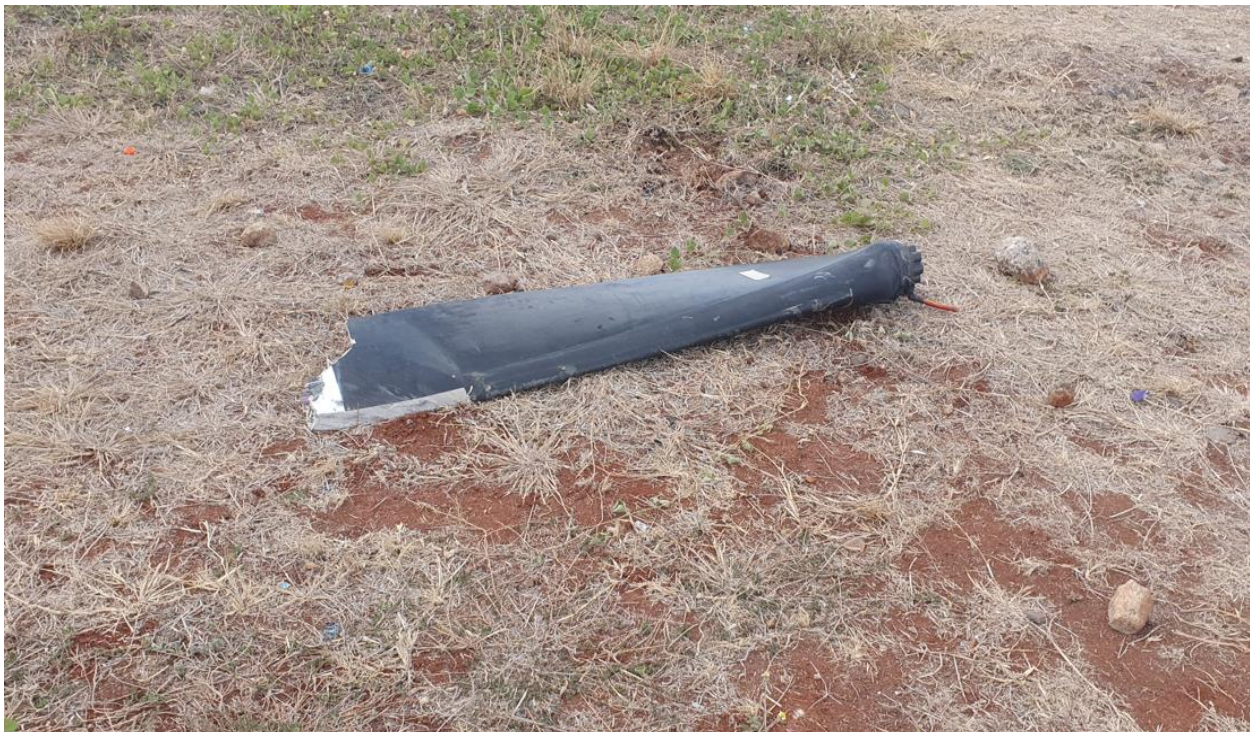
Figure 9: One of the propeller blades that separated from the aircraft
