AIRCRAFT ACCIDENT INVESTIGATION DEPARTMENT

PRELIMINARY INVESTIGATION REPORT

**ACCIDENT TO THE AIRCRAFT 5Y-KWL, AVIAT HUSKY A-1C 180 ON
11.02.2021 AT NANYUKI CIVIL AIRSTRIP, LAIKIPIA COUNTY**

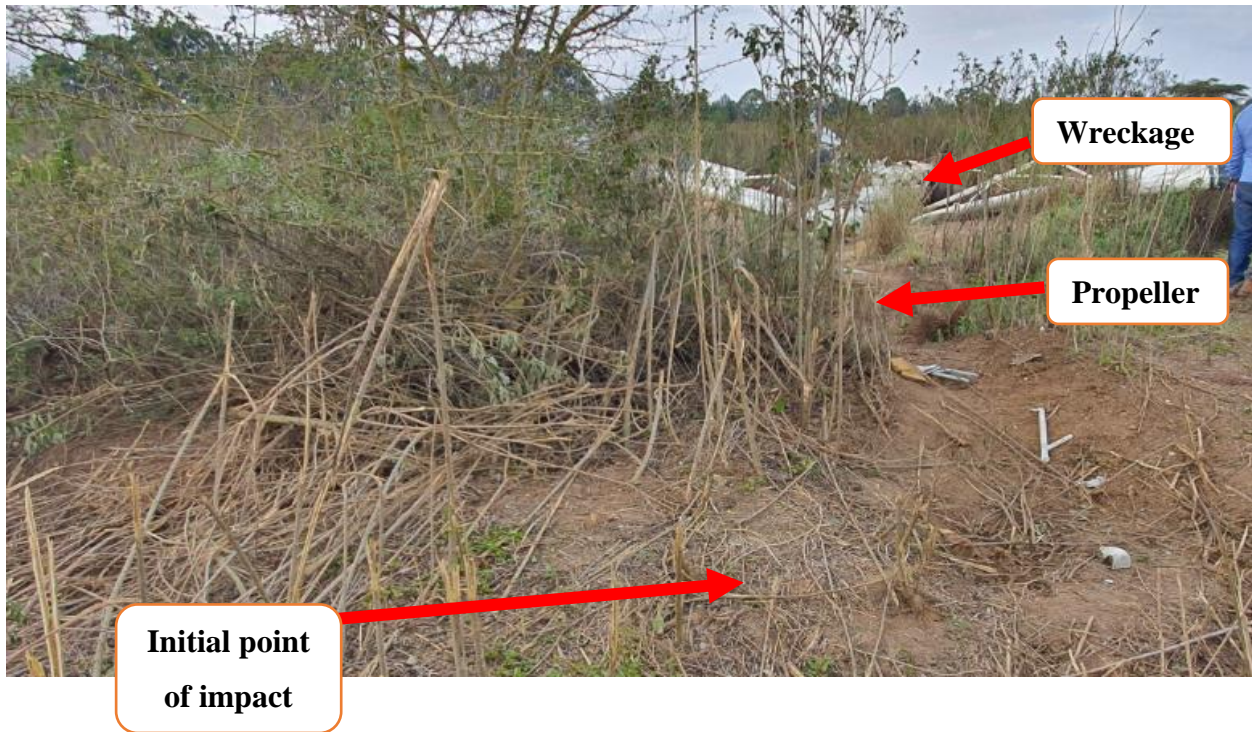
Examination of the accident site determined that on takeoff, the pilot banked to the left when he lost control of the aircraft before colliding with the terrain. It was evident that the aircraft impacted the ground at a high velocity, high angle. The wreckage was found in a grassy area within the confines of the Aerodrome. There was no pre or post-impact fire.

Figure 1: The Accident site within the Aerodrome

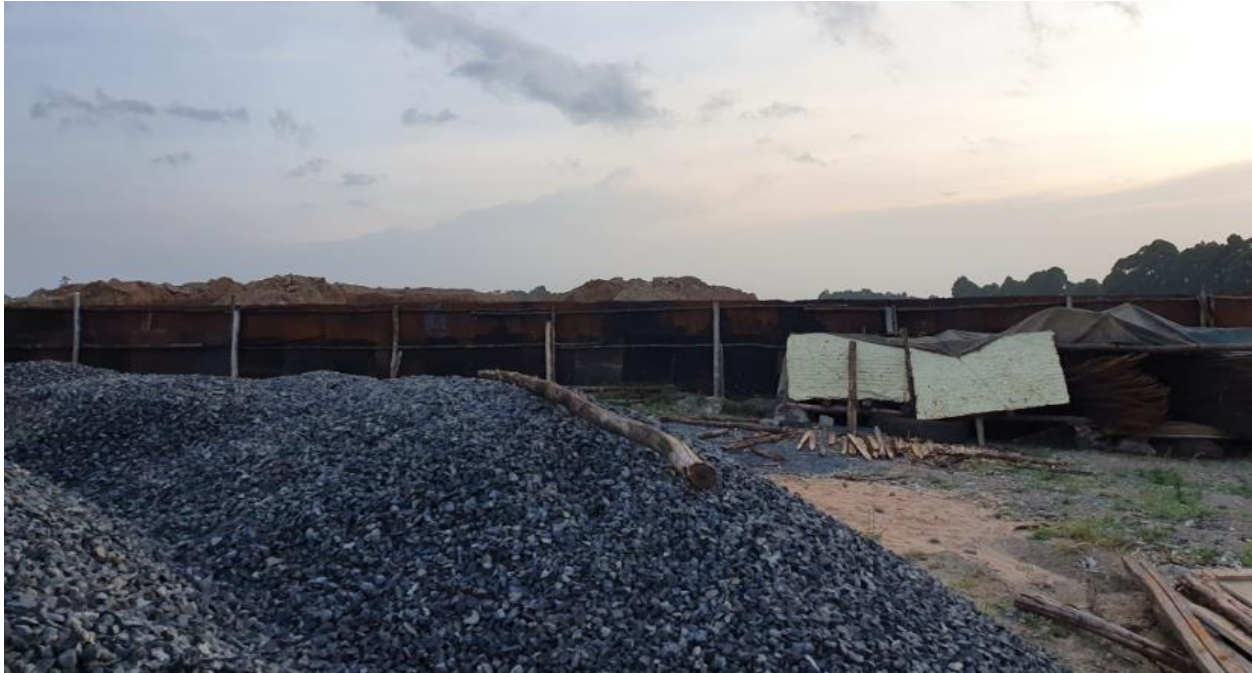
At about 1435 (1735), an eyewitness standing about 57metres north of the accident site saw an aircraft just to the east, travelling in an easterly direction, on a constant heading. He stated that the aircraft was banking to the left. The engine sounded as though it was faltering and stopped. He was visual with the aircraft throughout this time. It then disappeared from his view because of the barrier located in front of him.

Figure 2: The Location of the eyewitness

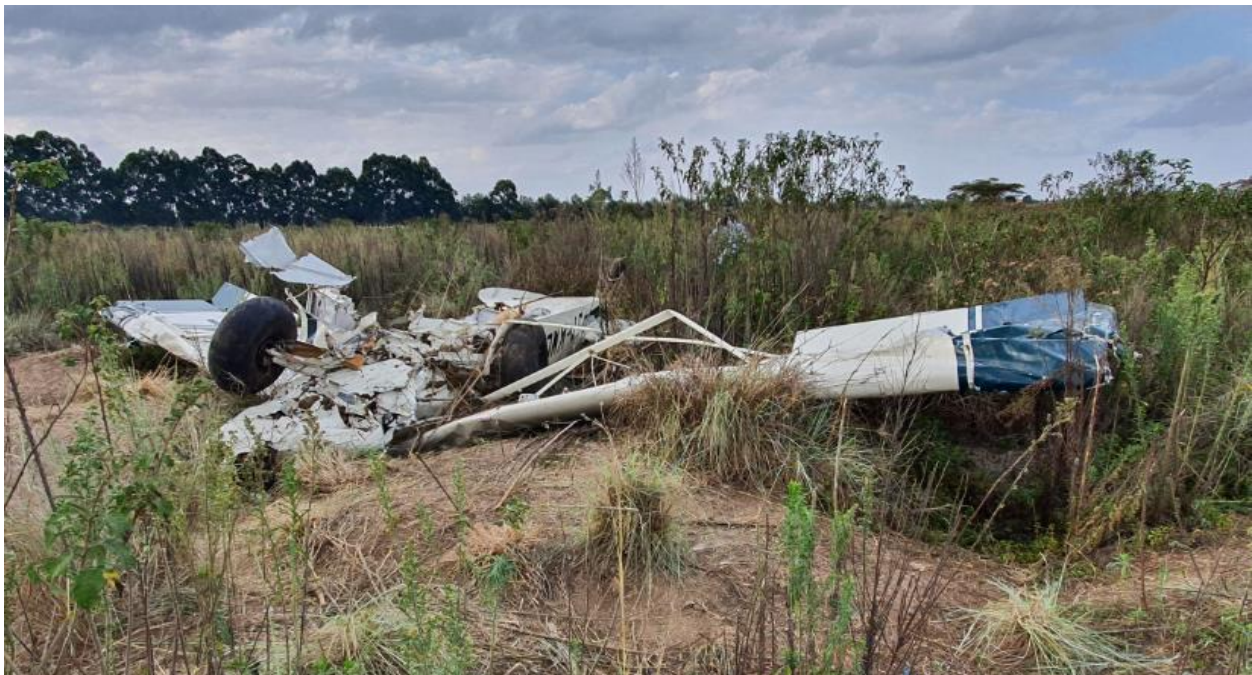
The aircraft wreckage was located within the aerodrome on the eastern side about 230metres from the end of runway 21 at an elevation of 1905ft AMSL (Figure 2) orientated in the direction of 196⁰(M)

The aircraft was destroyed on impact.

Figure 3: The wreckage of the aircraft in a grassy area within the confines of the Aerodrome

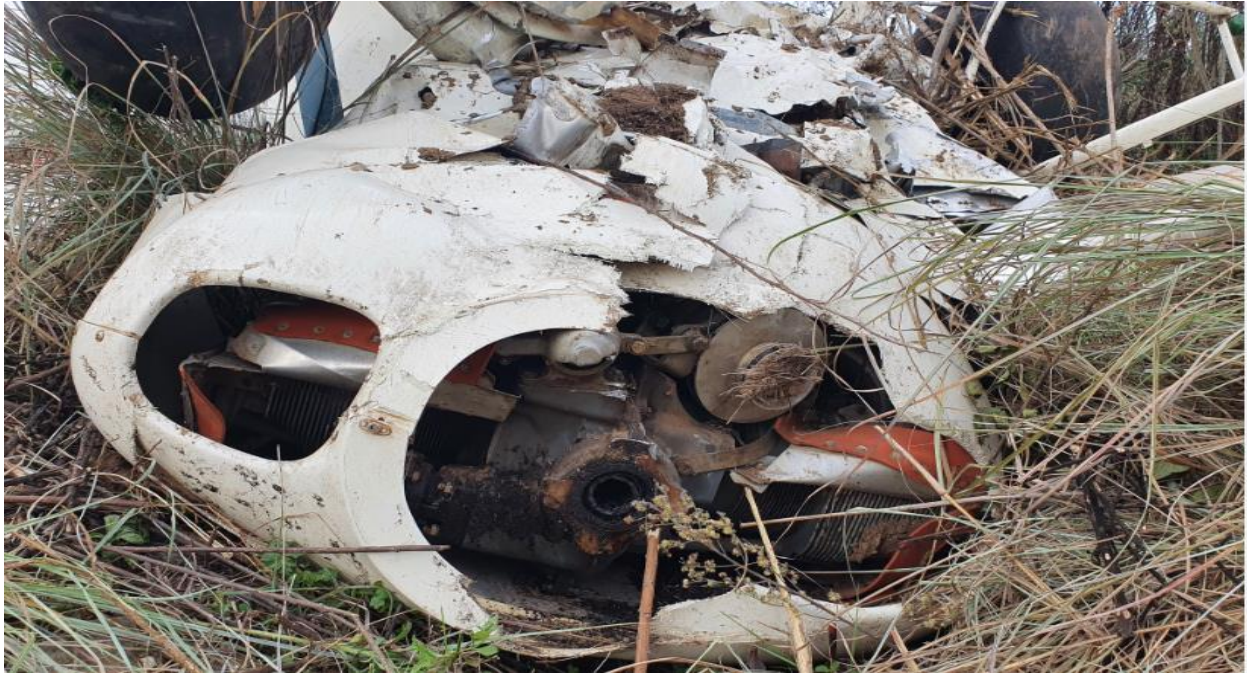
The aircraft impacted the ground and slid approximately 9.7 meters before coming to rest in an inverted position, with both the right and left wings resting on the ground. The airframe sustained significant damage to its nose; from the front instrument panel forwards it was almost disintegrated from the rest of the airframe. The left and rightwing leading edge sustained damage and the wingtips sustained impact damage. The entire propeller assembly separated from its attachment point on the hub. There was rotational damage and curling along the length of the propeller blades. The propeller assembly was found at 7.3 meters away from the initial point of impact and 2.4 meters to the main wreckage.

Figure 6: The Engine section of the aircraft after the accident.

From the initial onsite assessment of the wreckage, the occupied cabin area within the fuselage was compromised by the impact sequence. Figures 6 and 8 show how the forward floor of the cabin under the instrument panel was crushed when the nose gear collapsed. The impact had buckled the floor under the seats, and the fuselage was breached behind the rear cabin bulkhead. The instrument panels had become dislodged and pushed rearward on impact. The cabin roof and wings had moved forward as a result of the nose section of the aircraft impacting the ground thus reducing the cabin height. All of this damage reduced the survivable space within the cabin area.

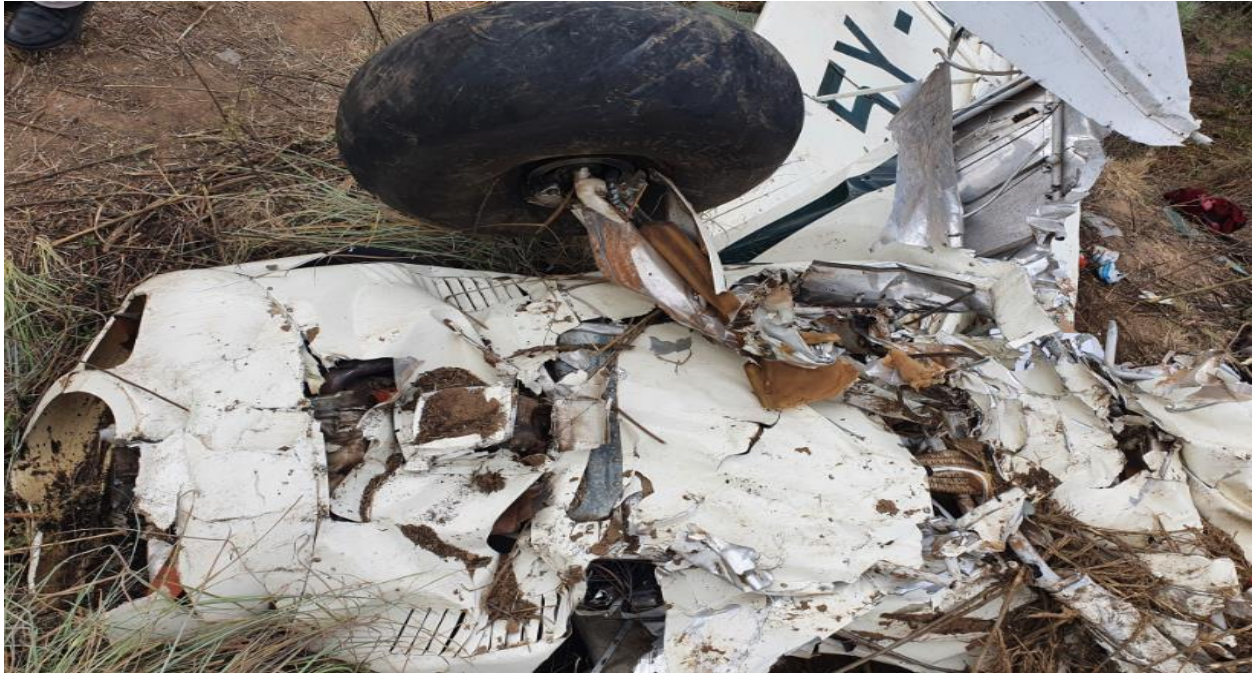
Figure 7: Wreckage damage to accident aircraft

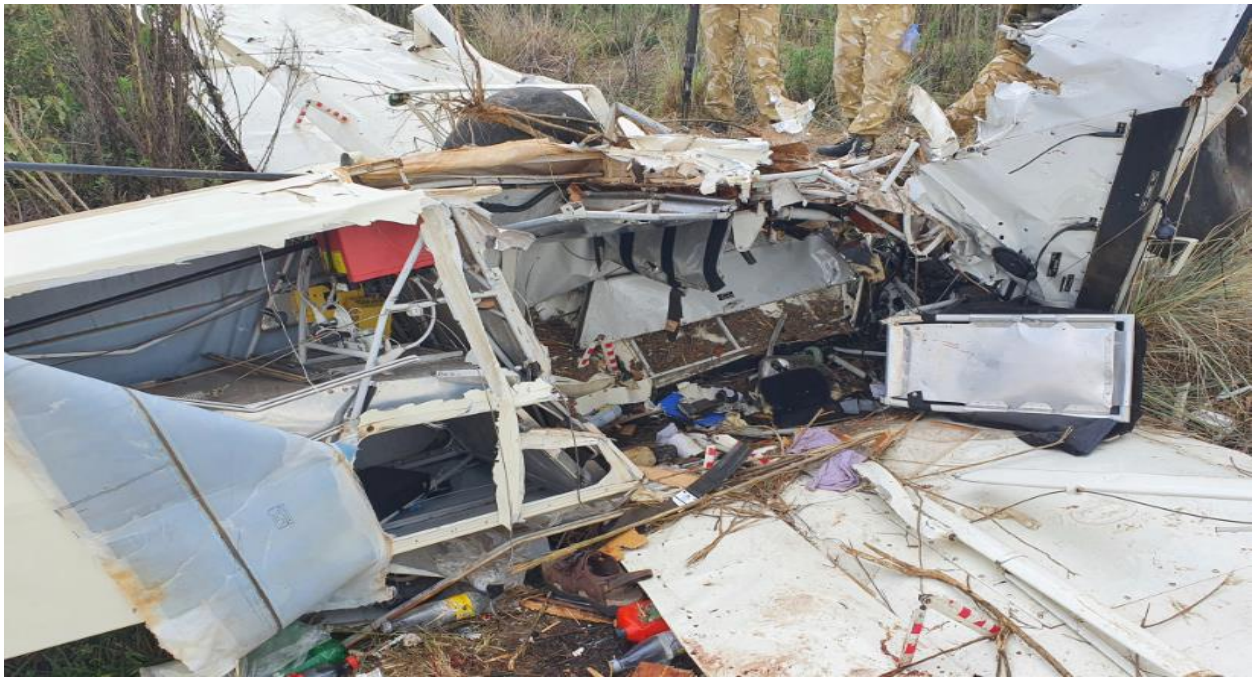
Figure 8: The section of the Cockpit after the accident.

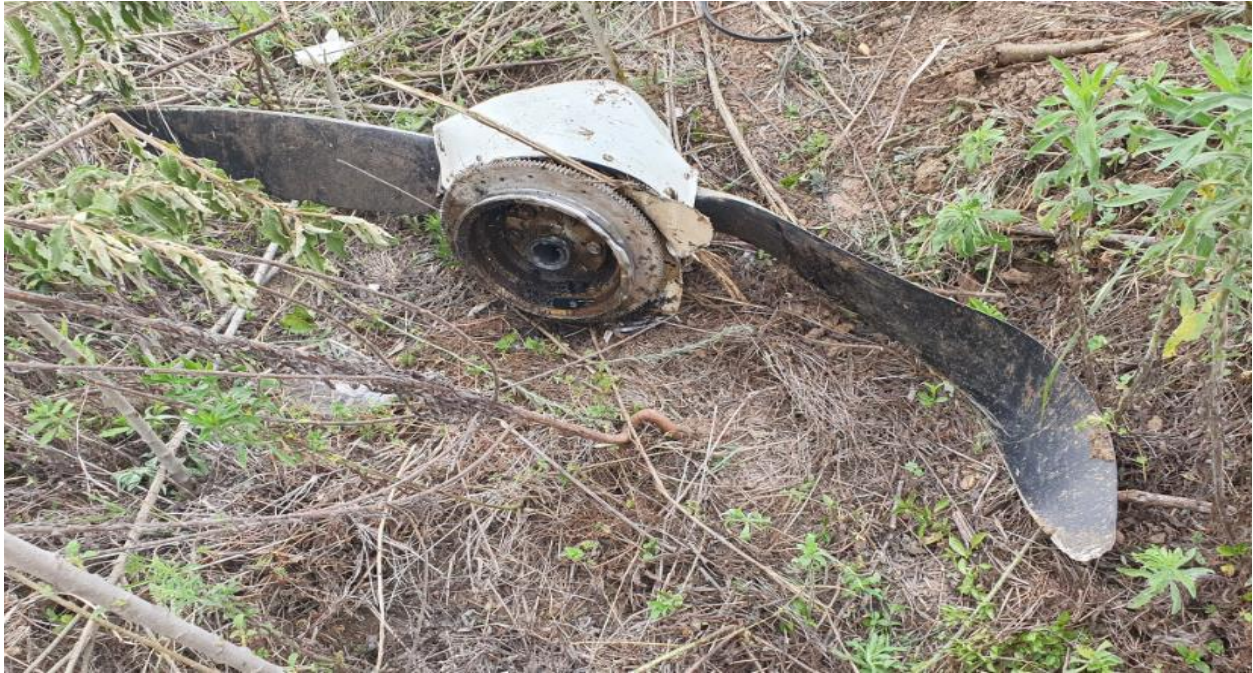
The ground impact marks showed that the aircraft struck the ground with the propeller first, at a steep angle; this was followed by a heavy nose impact (Figure 4). The aircraft had then flipped forward before turning in an inverted position resting inverted, and 9.7 m from the initial impact point.

Figure 9: Damaged propeller assembly

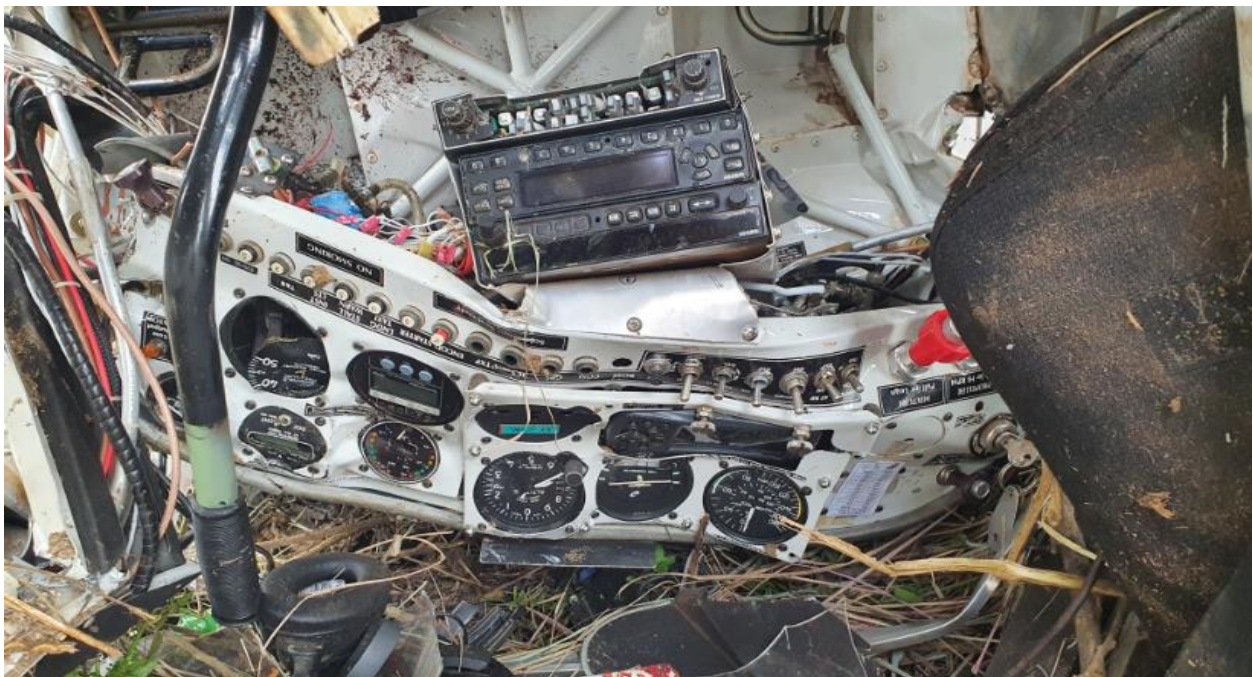
Figure 10: The Section of the Cockpit Instruments
