AIRCRAFT ACCIDENT INVESTIGATION DEPARTMENT

PRELIMINARY ACCIDENT REPORT

**PRELIMINARY INVESTIGATION REPORT OF AN OCCURRENCE
INVOLVING AN AEROANDINA MXP-1000 TAYRONA MICROLITE,
REGISTRATION 5Y-VBB ON 09 DECEMBER 2020 ALONG
FOREST ROAD IN ISIOLO**

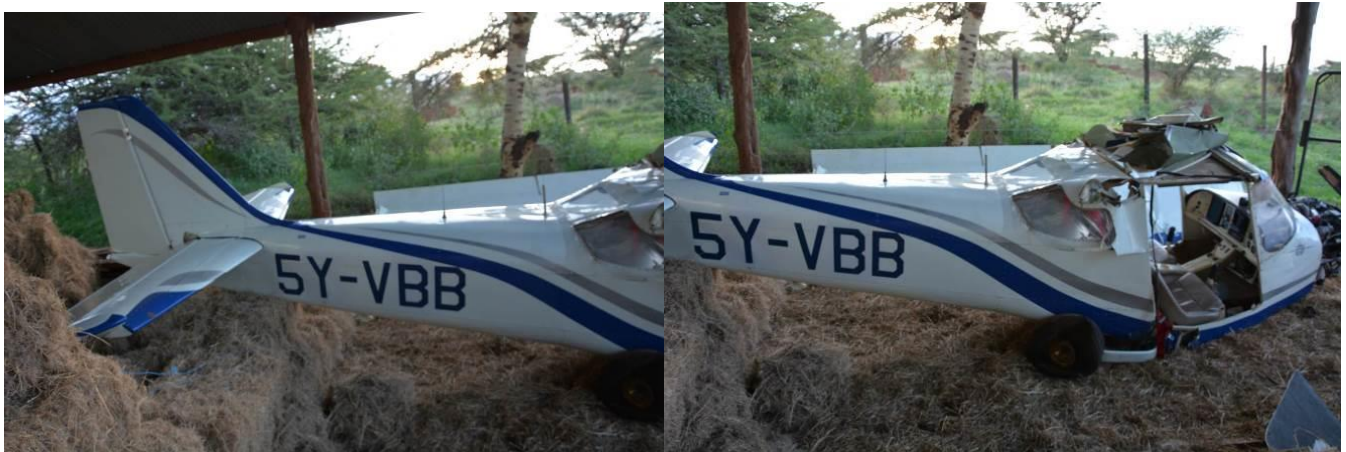
FIGURE No. 2 – A photo of tail section of Aircraft 5Y-VBB after recovery from the accident site and

FIGURE No. 3 – A photo depicting extent of damage to the aircraft's fuselage

The aircraft sustained substantial damage. It came to rest with the nose wheel struck off from its assembly, three of the four composite propeller blades severed at their root and the forth one severed at two thirds along its length. Further damage was to the lower section of the engine thus affecting the thrust line. The main landing gear was bent backwards as it absorbed much of the impact forces while the cockpit area was largely intact. The wings were damaged both at the tip and at the root and wrinkled at various points and the windscreen was shattered. The tail section of the aircraft was largely intact, save for some wrinkling.

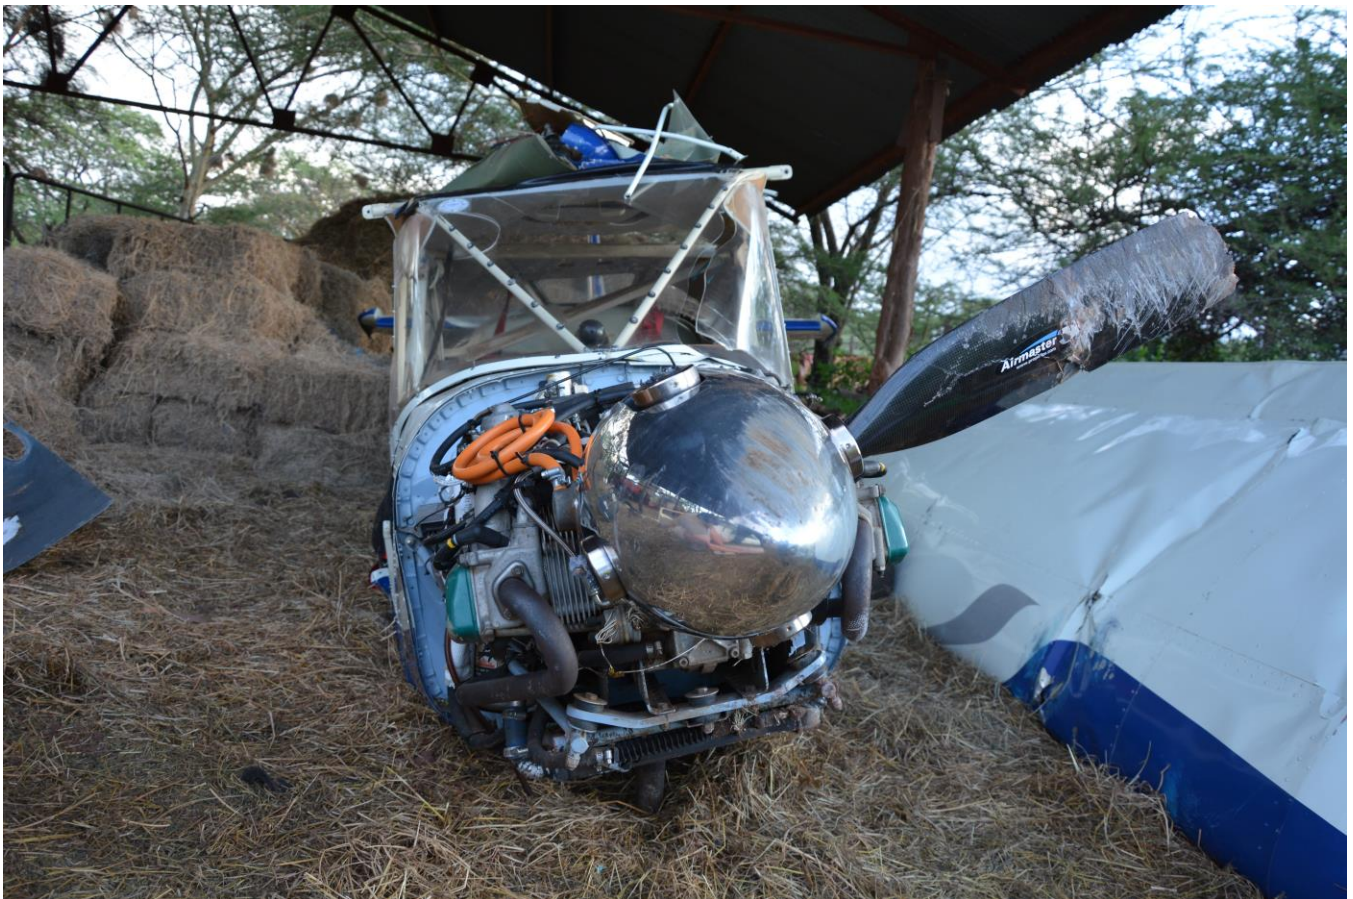
FIGURE No. 4 – A photo depicting extent of damage to the propeller, engine, cockpit area, wing and fuselage roof
