AIRCRAFT ACCIDENT INVESTIGATION

PRELIMINARY ACCIDENT REPORT
ON A CESSNA 172 REGISTRATION 5Y-CII WITH 3PERONS ONBOARD AT EWAAT
MAUCHE NAKURU KENYA
ON 13TH AUGUST 2022

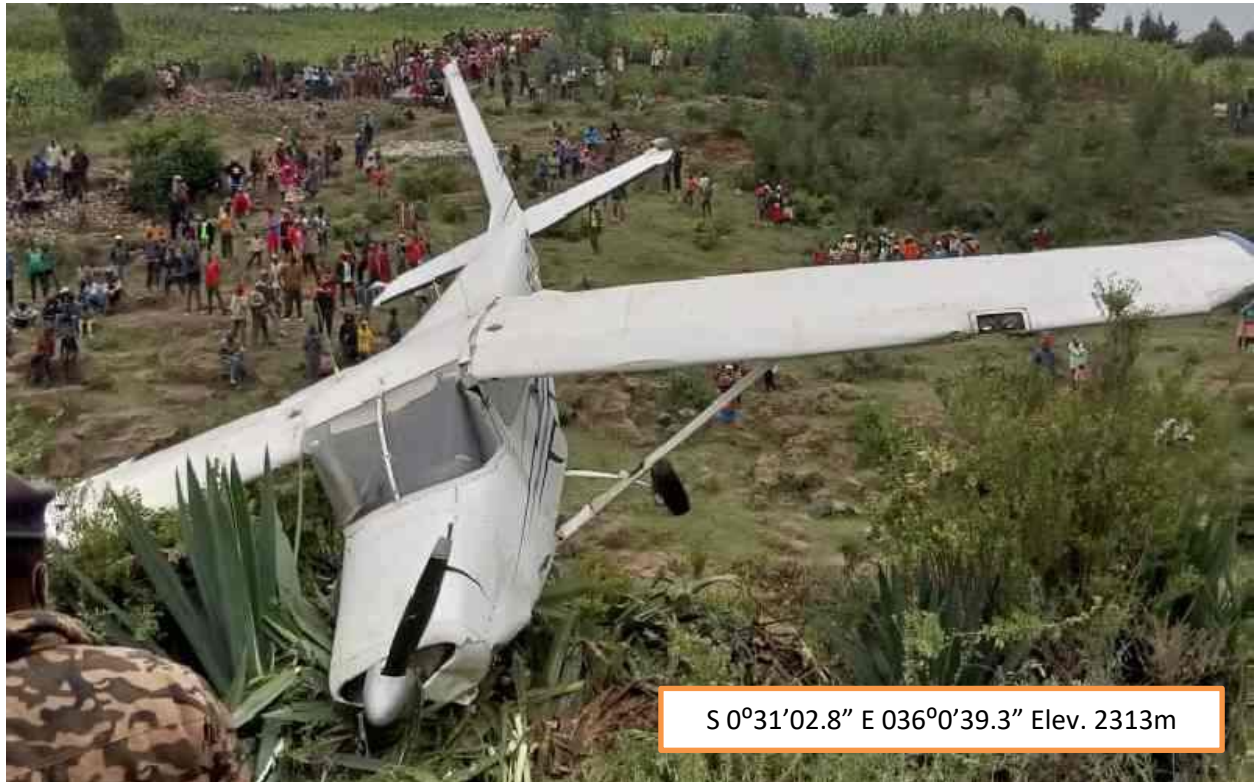
Figure 1: photograph of the accident aircraft at the accident site

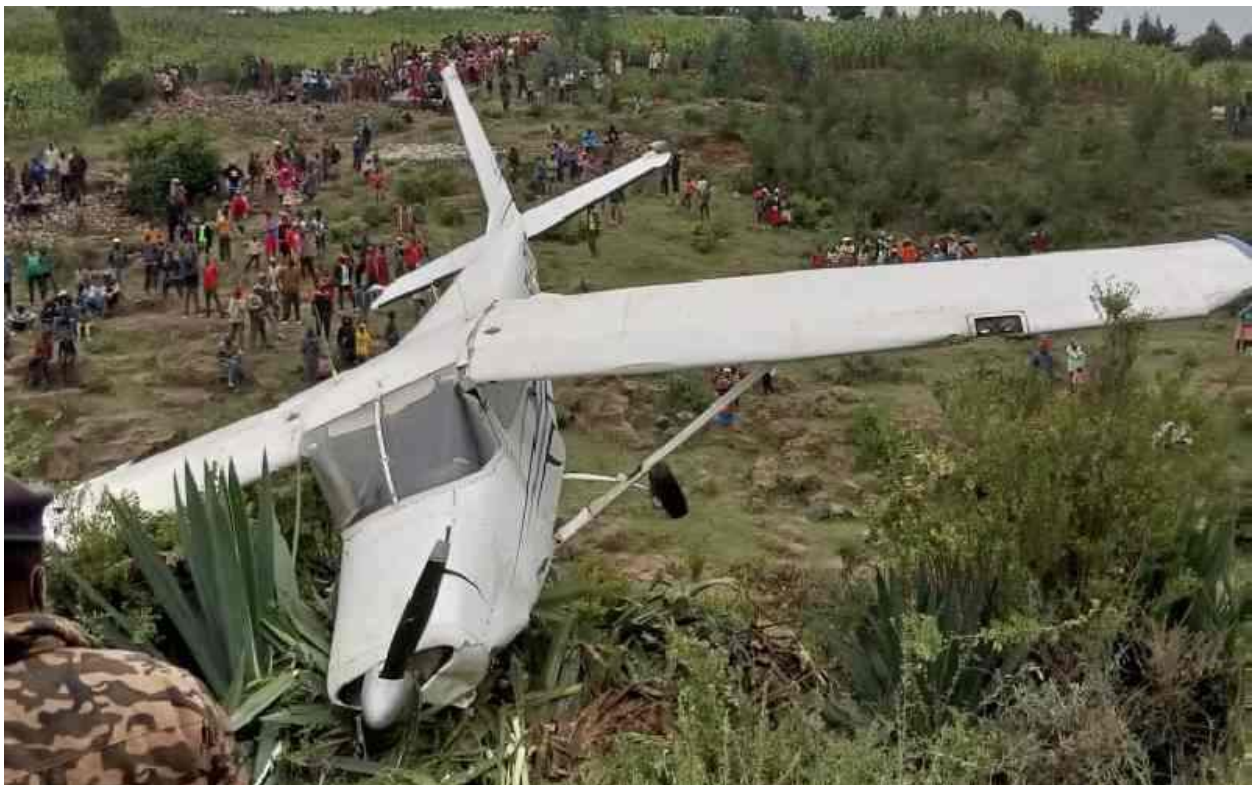
Figure 3: Photograph showing the damage of the accident aircraft at the accident site.

The aircraft impacted a thicket of sisal plantaion that acted as a shock absorber and dampened impacted forces. The lef wing bent at the fuselage joint. The head-light also broke off. The left strut also got a significant bent bjut did not break.

The right wing got dented at the tip and the mid-way. The empanage was general intact without any noticeable breakage or dent. There was no any noticeable bent or dent on the propellers.
