Aircraft Accident Investigation Preliminary Accident Report 5Y-KDL 03.03.2019

BELL 505

CENTRAL ISLAND NATIONAL PARK, TURKANA

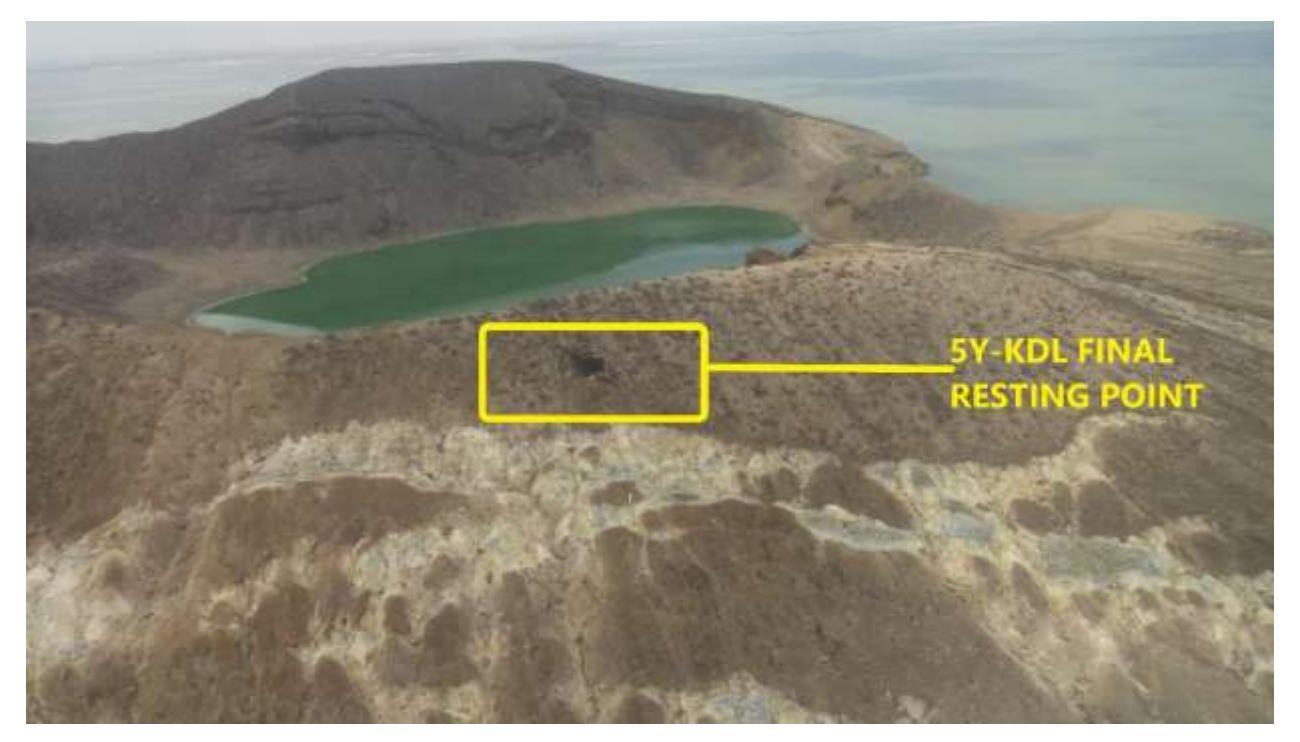
Figure 1: Aerial view of the helicopter's final resting point on Central Island.

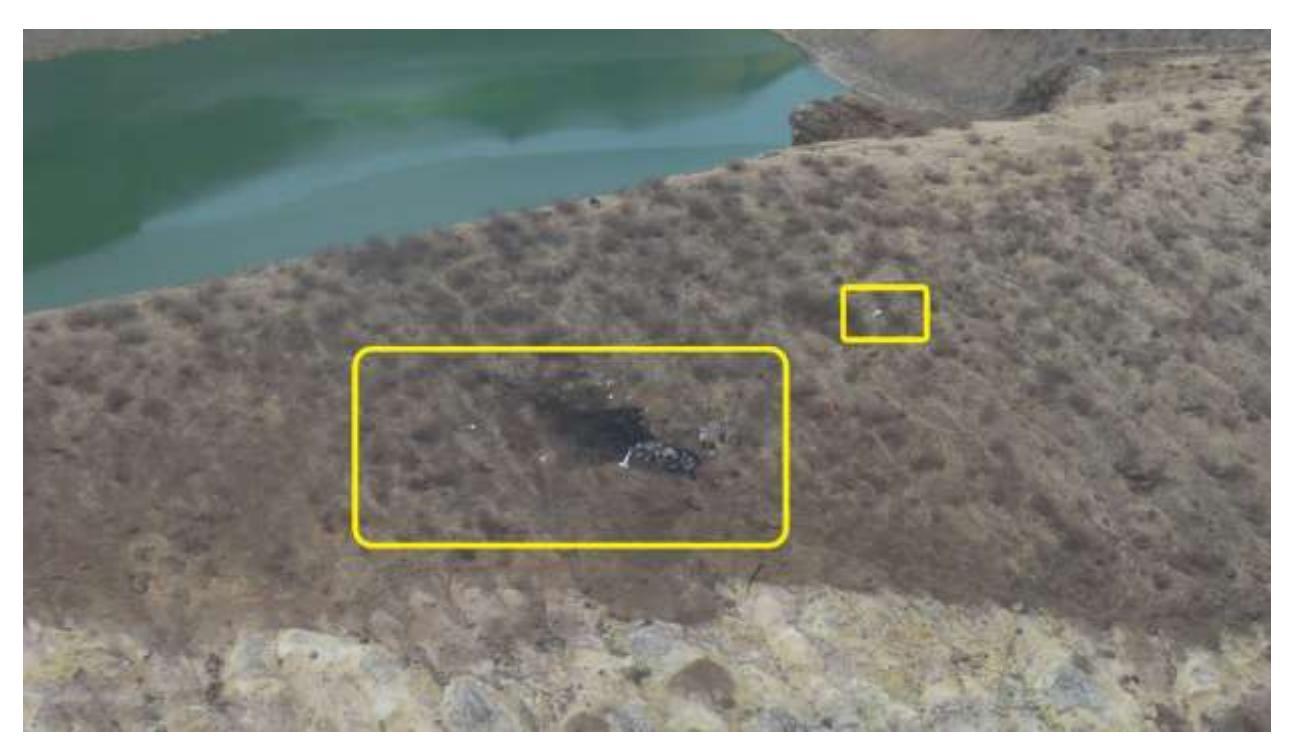
Figure 2: Aerial view of the helicopter's wreckage at the Central Island. (closer view)

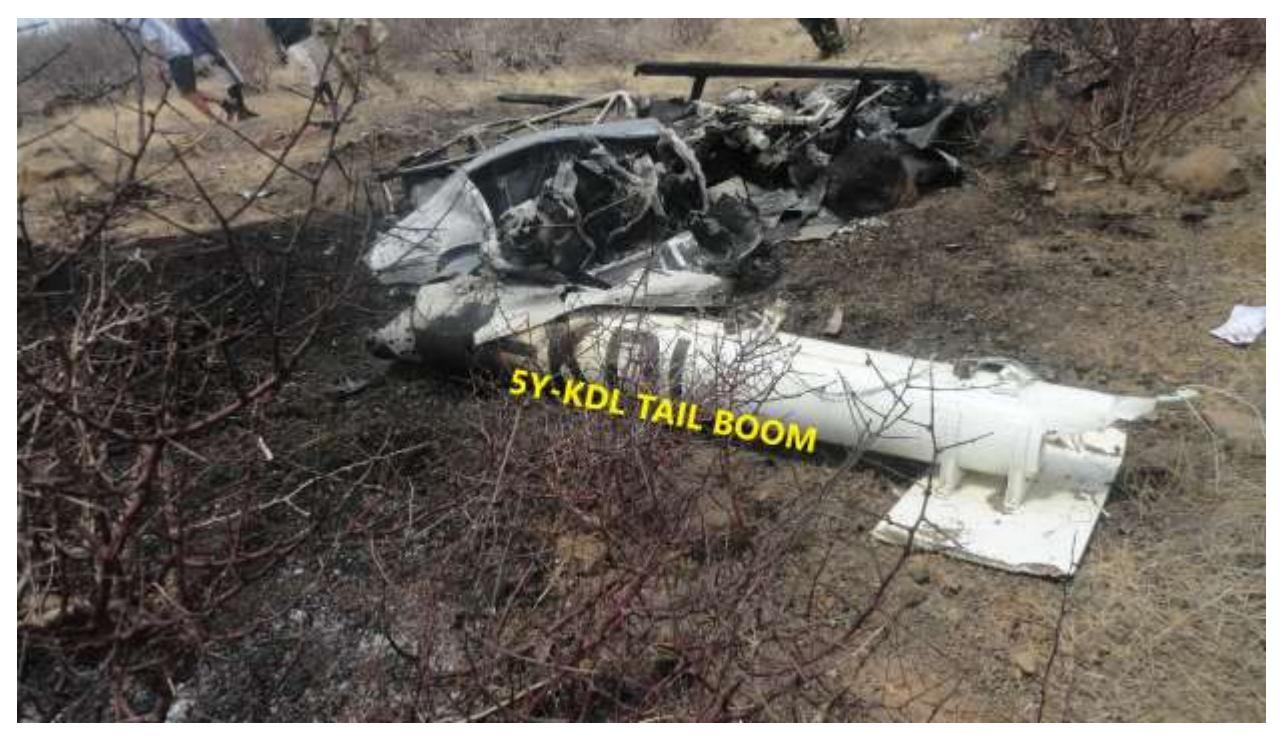
The aircraft was destroyed.

Figure 3: The wreckage of the damaged aircraft

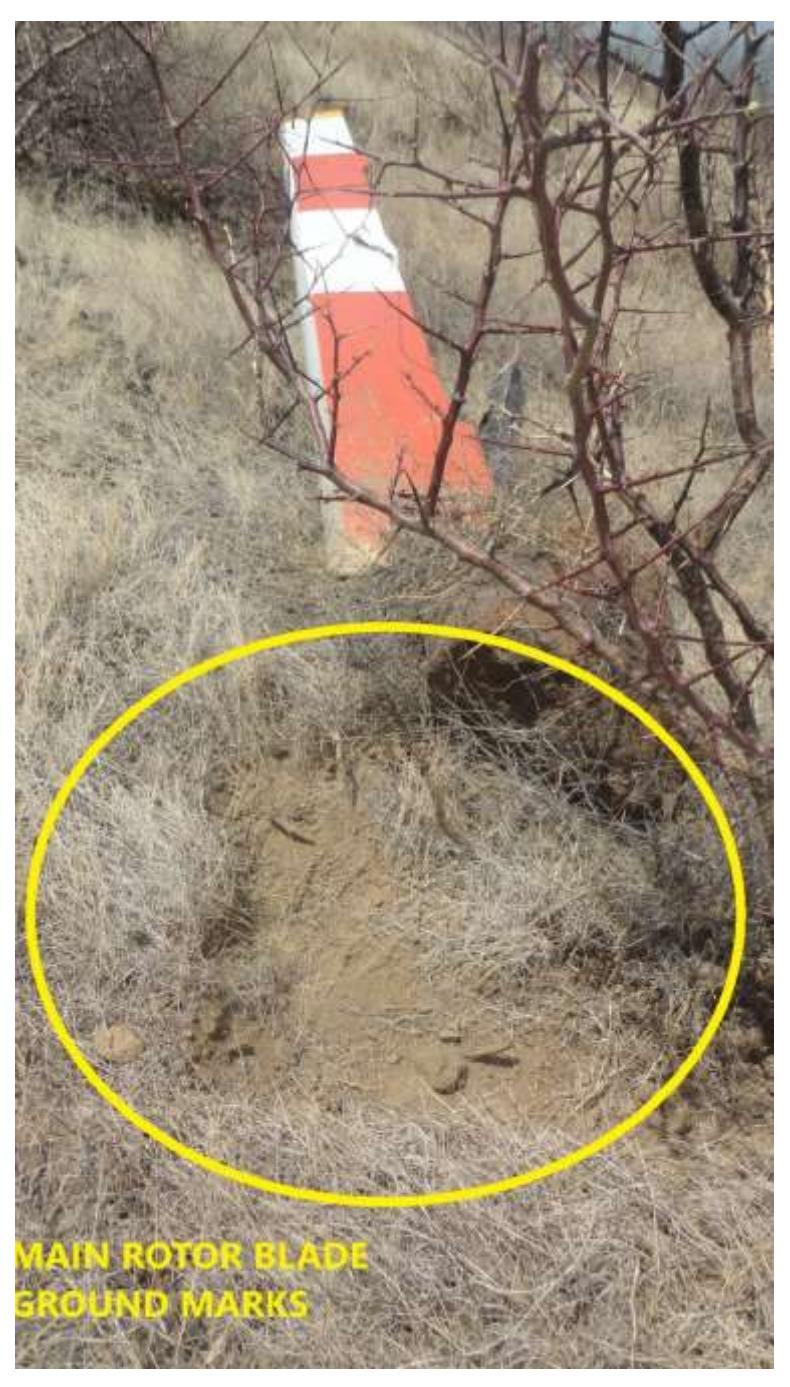
- (1) The tail boom was severed near its aft end
- (2) One main rotor blade separated rotor hub leaving evidence of the twisted fibre material.
- (3) The mast separated from the swashplates
- (4) One main rotor blade had broken off near its attachment to the hub
- (5) The other main rotor blade suffered a longitudinal crack and broke of at the tip.
- (6) The rubber casing covering the mast had completely separated from the aircraft.
- (7) The tail rotor component assembly was found to be generally intact with the crosshead, pitch change links and the tail rotor gearbox connector shaft
- (8) At the point of impact, visual examination of the engine indicated that at the time of impact, the engine was under significant power

Figure 6: Broken main rotor blade and the resultant ground mark.

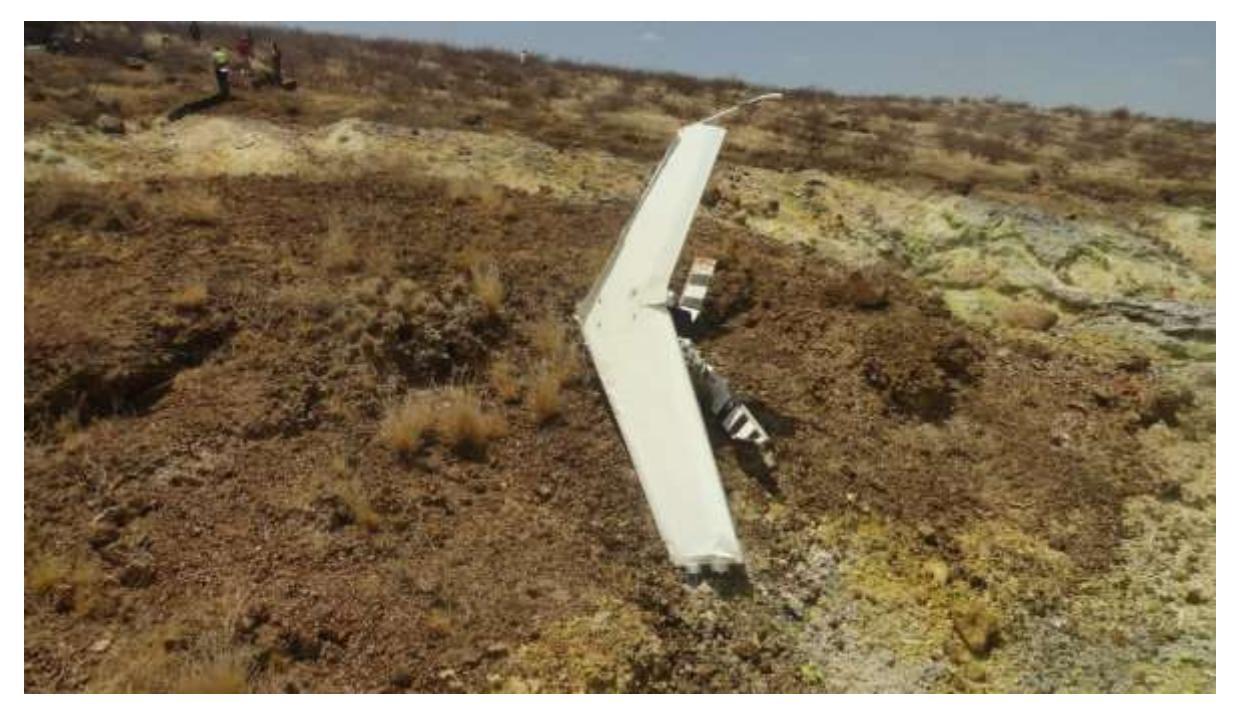
The vertical stabilizer and tail rotor were found detached from the tail boom 54 meters from the main wreckage location.

Figure 7: Detached empennage section

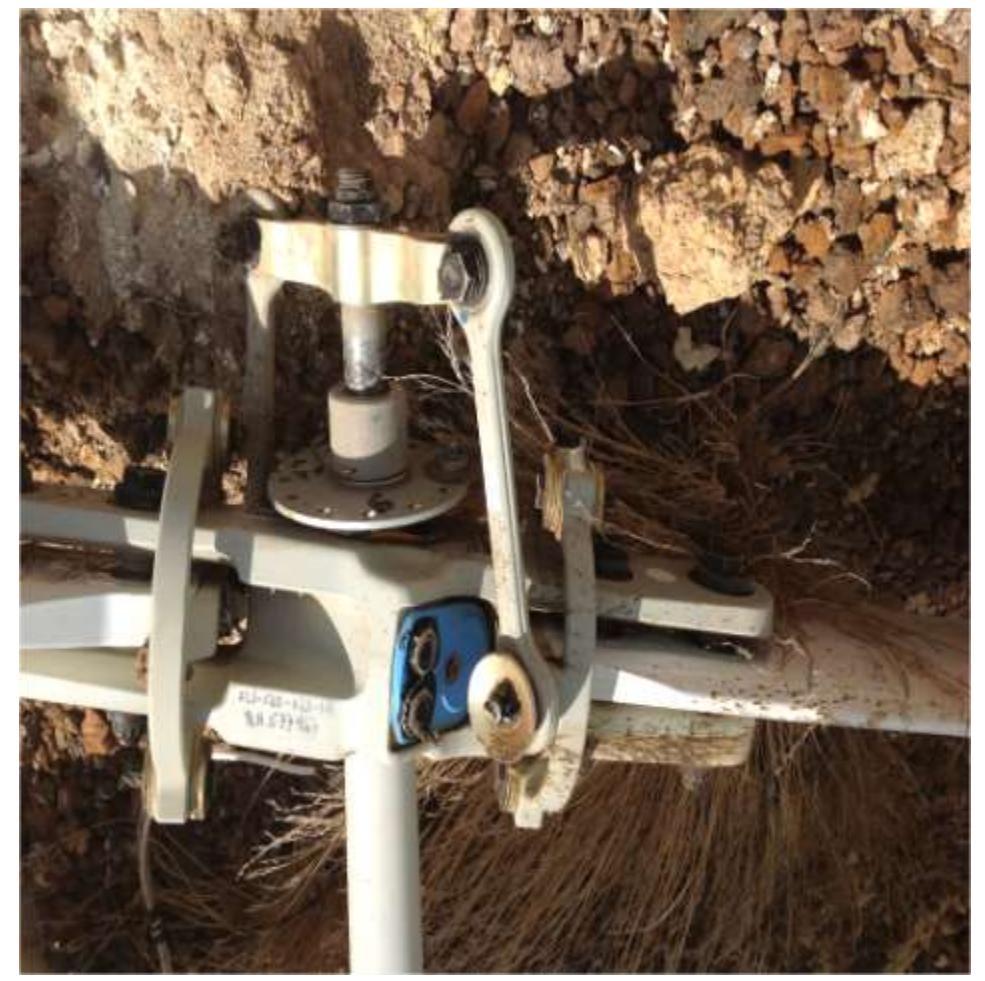
Figure 8: Tail rotor component assembly

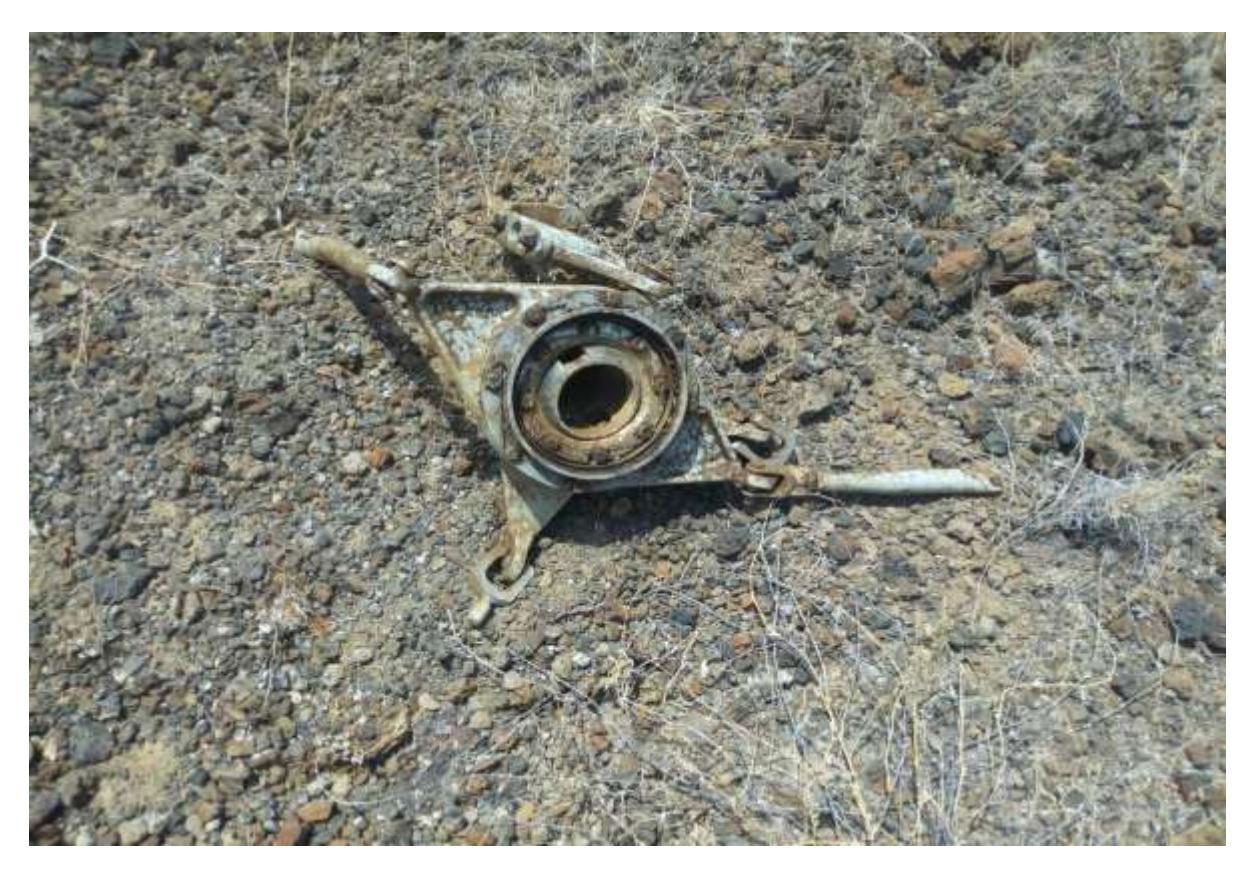
Figure 9: Damaged lower swashplate (static) and connecting rods

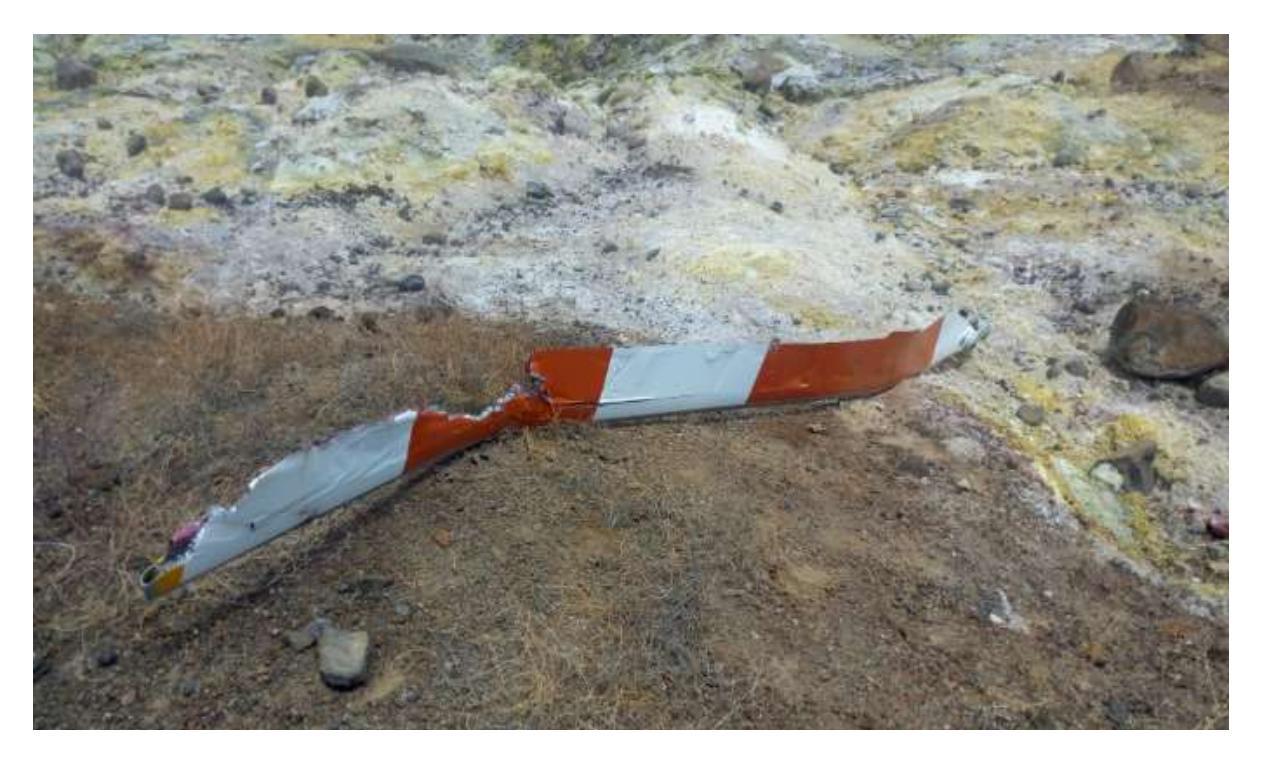
Figure 10: Broken main rotor blade found 12 metres from the main wreckage

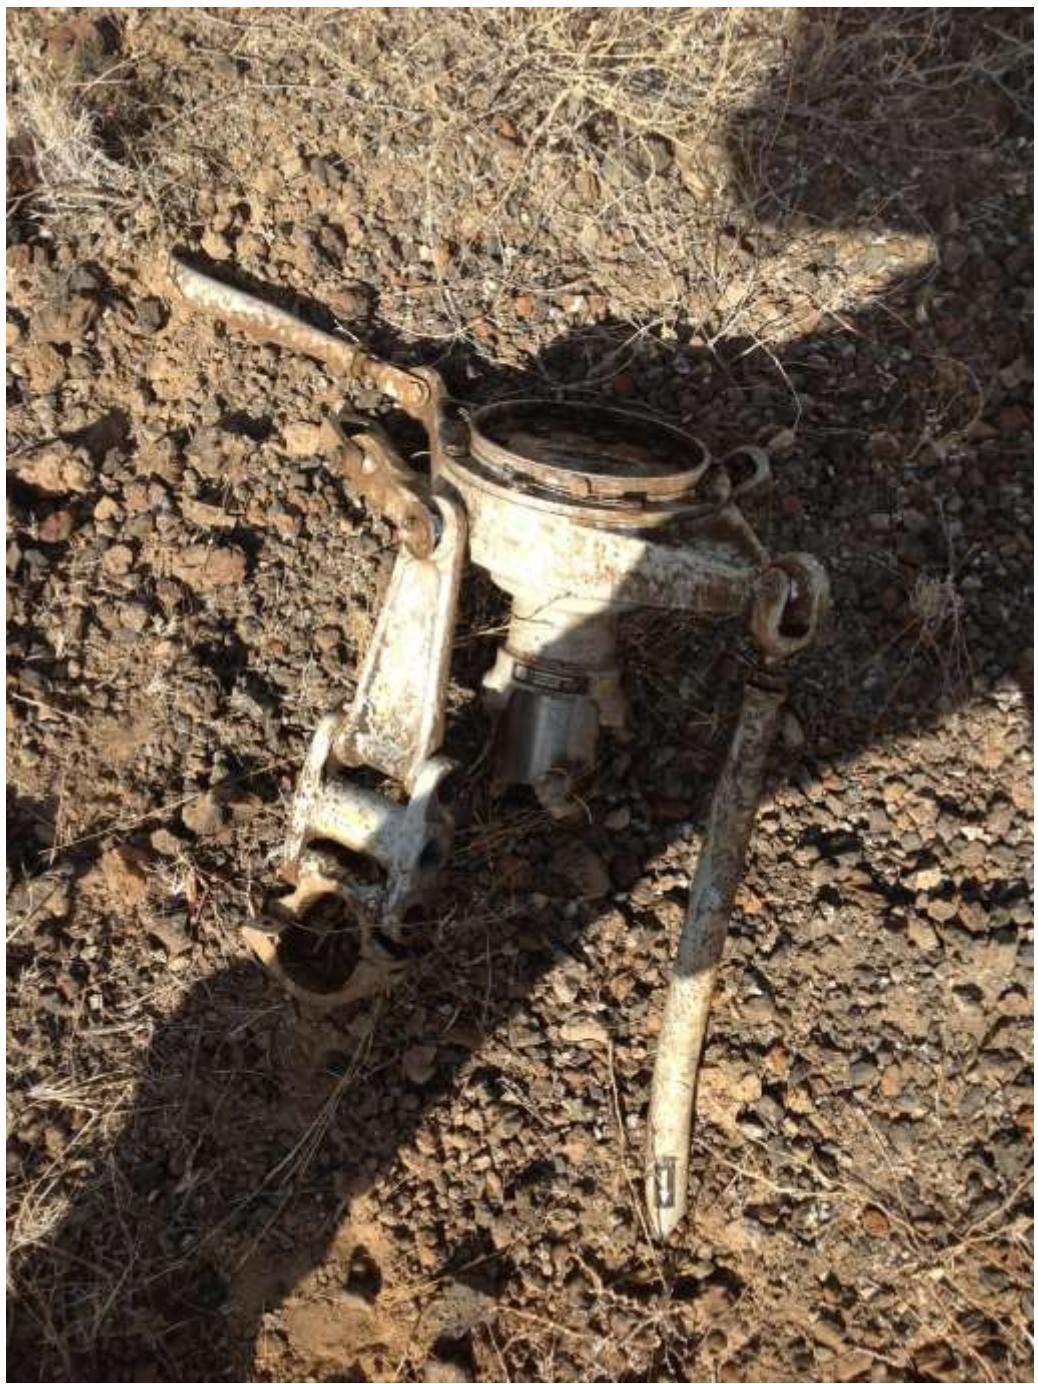
Figure 10: Damaged upper swashplate (movable)

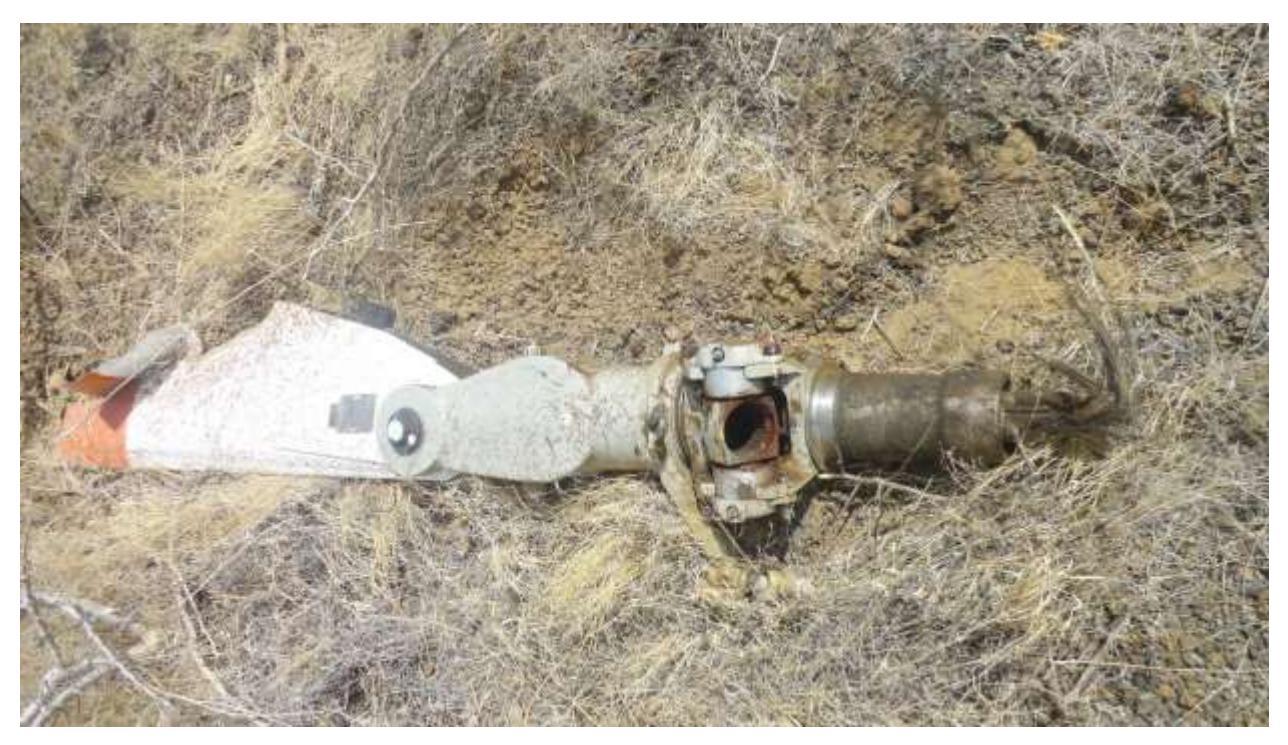
Figure 12: High impact damage to the main rotor blades at their attachment location
