ACCIDENT REPORT

5Y-UVP

22.08.2012

AIR ACCIDENT INVESTIGATION DEPARTMENT

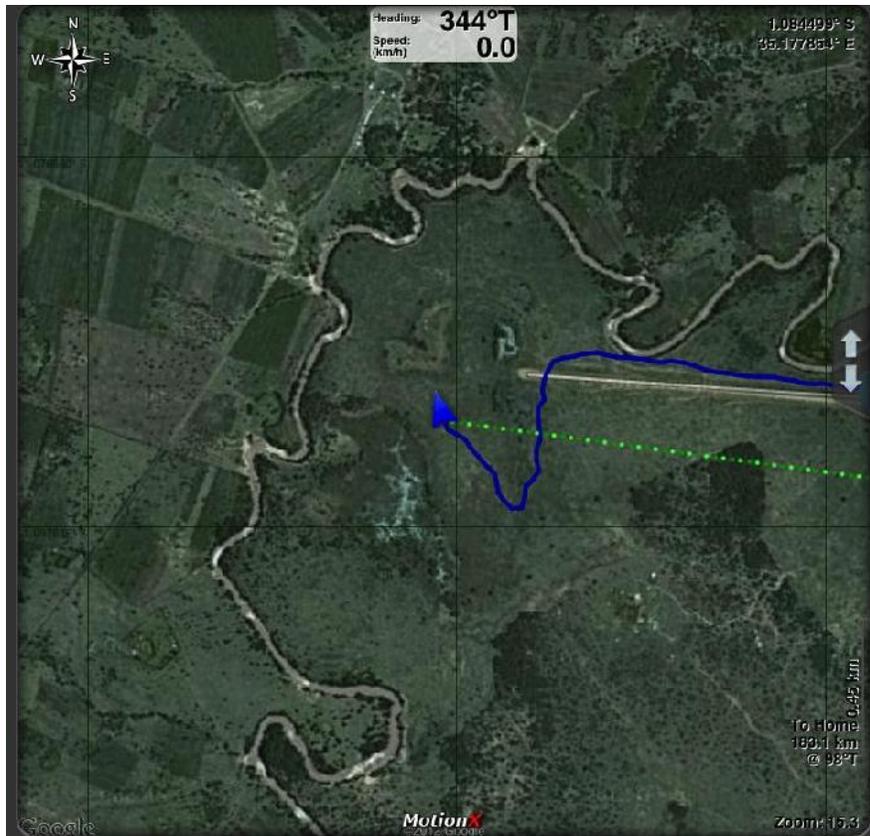
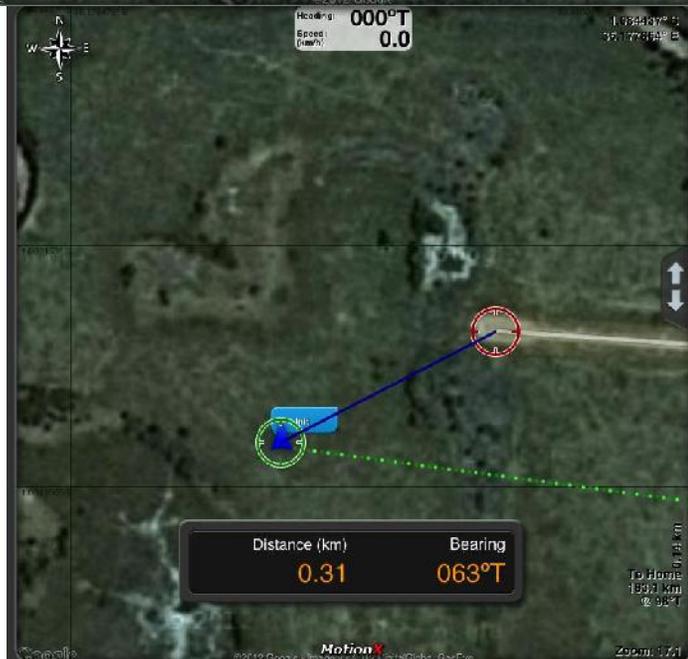
figure 1.2 : Accident site distance and location on google maps

GPS coordinates (figure 1.2) 01.084189° S, 35.1781127° E, Ngerende airstrip.
