**MINISTRY OF ROADS AND TRANSPORT  
STATE DEPARTMENT FOR TRANSPORT  
AIRCRAFT ACCIDENT INVESTIGATION DEPARTMENT**

**INVESTIGATION REPORT 01/03/2024 - Rev 1**

**PRELIMINARY INVESTIGATION REPORT ON THE MIDAIR  
COLLISION ACCIDENT INVOLVING CESSNA C172M AIRCRAFT  
REGISTRATION 5Y-NNJ AND BOMBARDIER DE HAVILLAND  
DASH 8 DHC 8-315 AIRCRAFT REGISTRATION 5Y-SLK, ON  
05MARCH 2024 AT THE NAIROBI NATIONAL PARK, NAIROBI  
COUNTY**

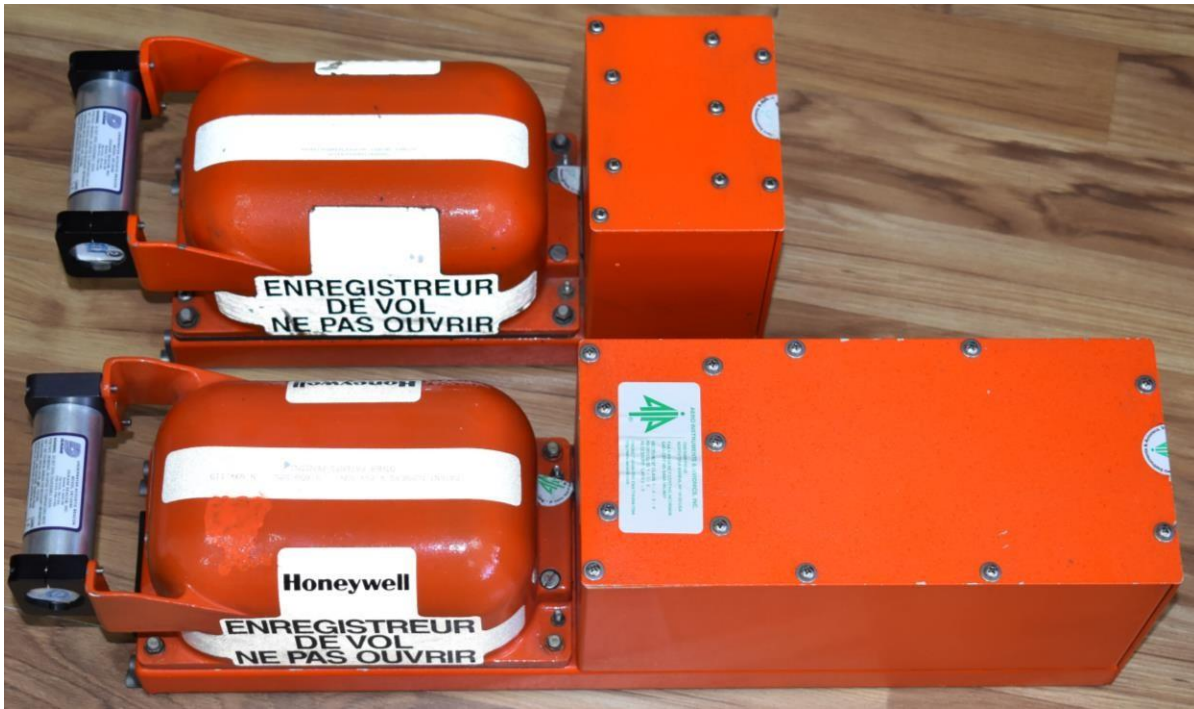
*FIGURE No. 9 – A photo depicting the Cockpit Voice Recorder (upper) and Flight Data Recorder*

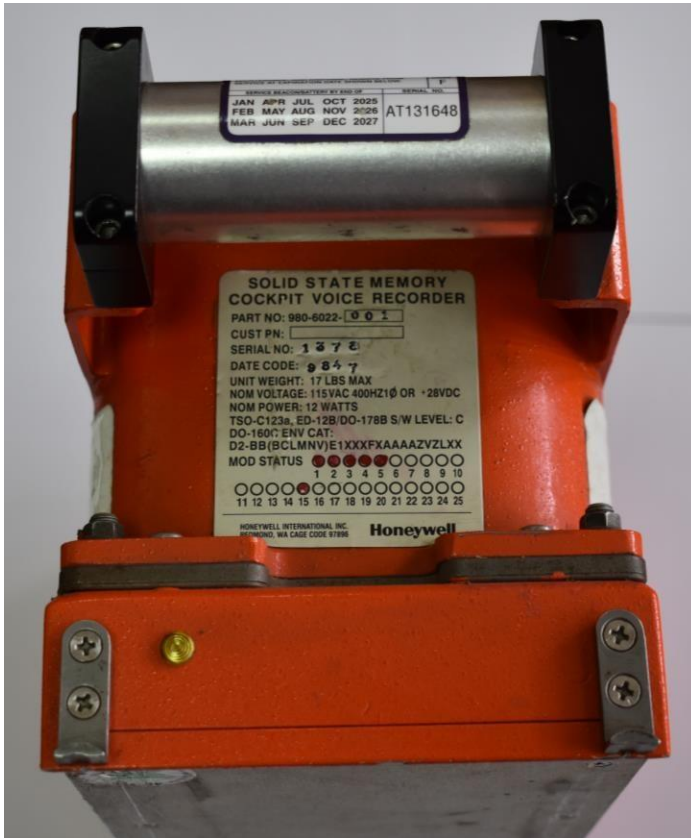
**FIGURE No. 10 – A photo depicting the Cockpit Voice Recorder**

A Honeywell solid state memory Cockpit Voice Recorder (CVR) Part No. 980-6022-001, Serial No. 1378, data code 9847 was recovered from the aircraft in good condition. The CVR will be read out and analysed as early as possible in a read-out facility at the TSB-Canada under the supervision of the Investigator-In-Charge (IIC).

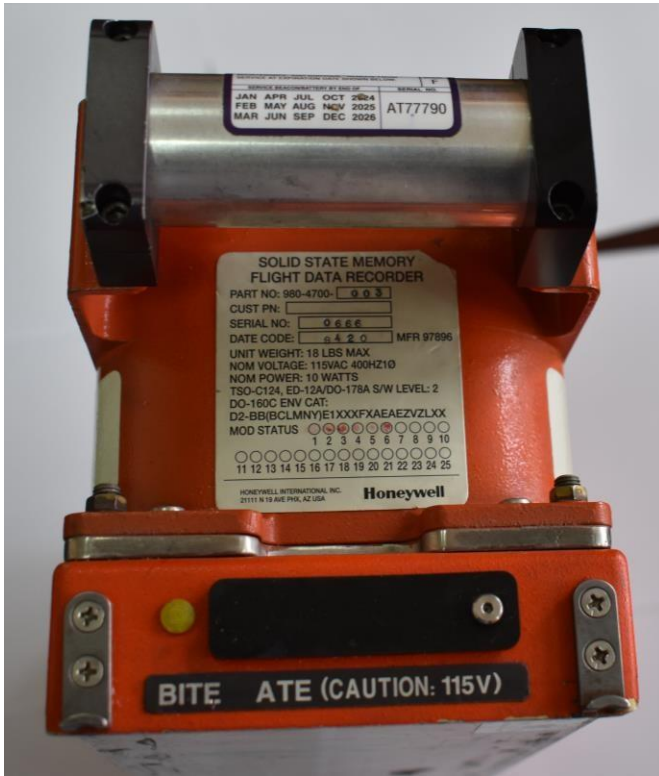
**FIGURE No. 11 – A photo depicting the Flight Data Recorder**

A Honeywell solid state memory Flight Data Recorder (FDR) Part No. 980-4700-003, Serial No. 0666 data code 9420 (MFR 97896) was recovered from the aircraft in good condition. The FDR will be read out and analysed as early as possible in a read-out facility at the TSB-Canada under the supervision of the Investigator-In-Charge (IIC).
