AIRCRAFT ACCIDENT INVESTIGATION DEPARTMENT

PRELIMINARY ACCIDENT REPORT

**PRELIMINARY INVESTIGATION REPORT OF AN OCCURRENCE
INVOLVING AN AEROANDINA MXP-1000 TAYRONA MICROLITE,
REGISTRATION 5Y-VBB ON 09 DECEMBER 2020 ALONG
FOREST ROAD IN ISIOLO**

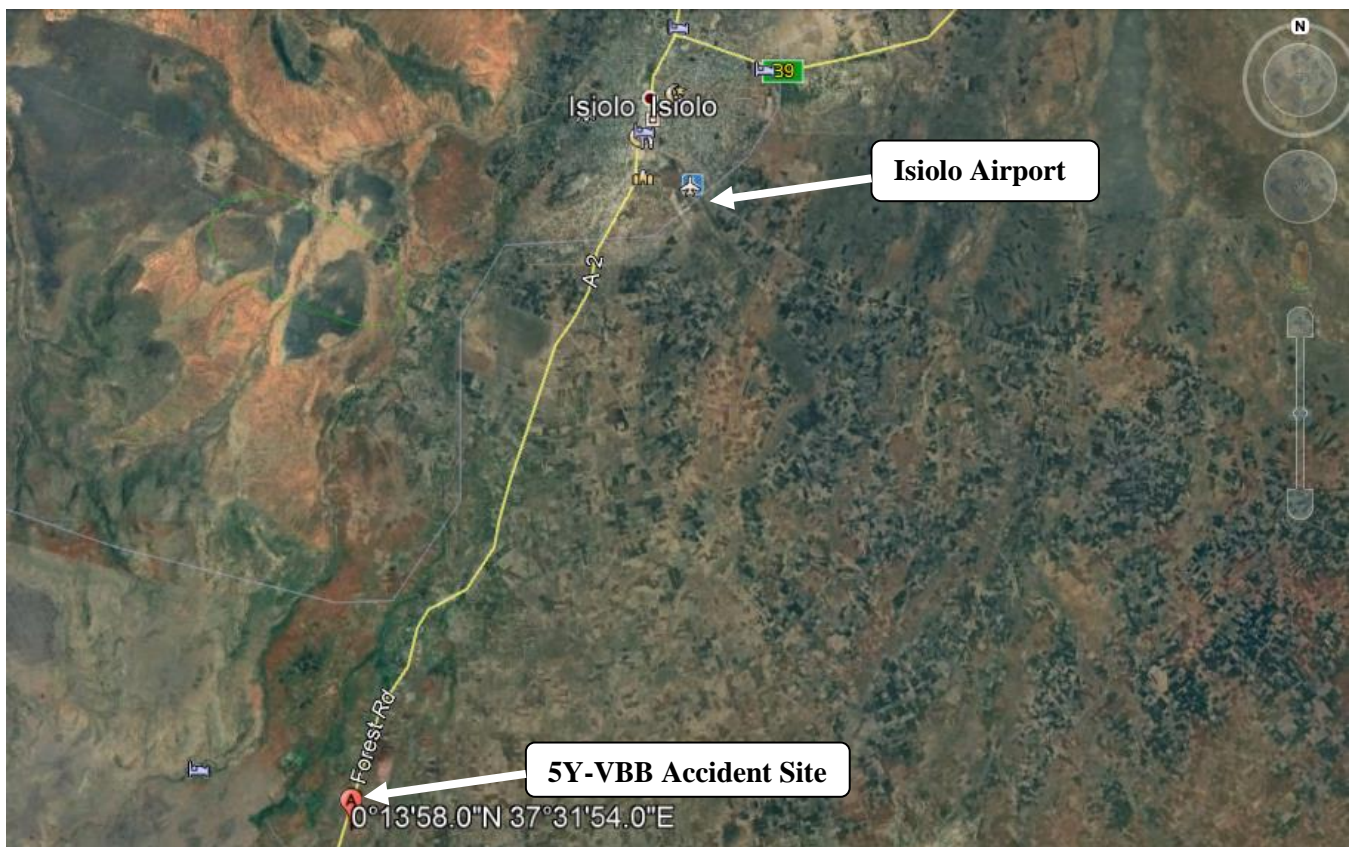
FIGURE No. 1 – Aerial View of Accident site (source: Google earth, with AAID annotations)

The accident site location is 7.30 NM, heading 208° from Isiolo airport on a road with a raised gradient and a ditch besides it. Damage to the aircraft was exacerbated on veering off to the ditch where the aircraft came to rest.
