AIRCRAFT ACCIDENT INVESTIGATION

PRELIMINARY ACCIDENT REPORT
ON A CESSNA 172 REGISTRATION 5Y-CII WITH 3PERONS ONBOARD AT EWAAT
MAUCHE NAKURU KENYA
ON 13TH AUGUST 2022

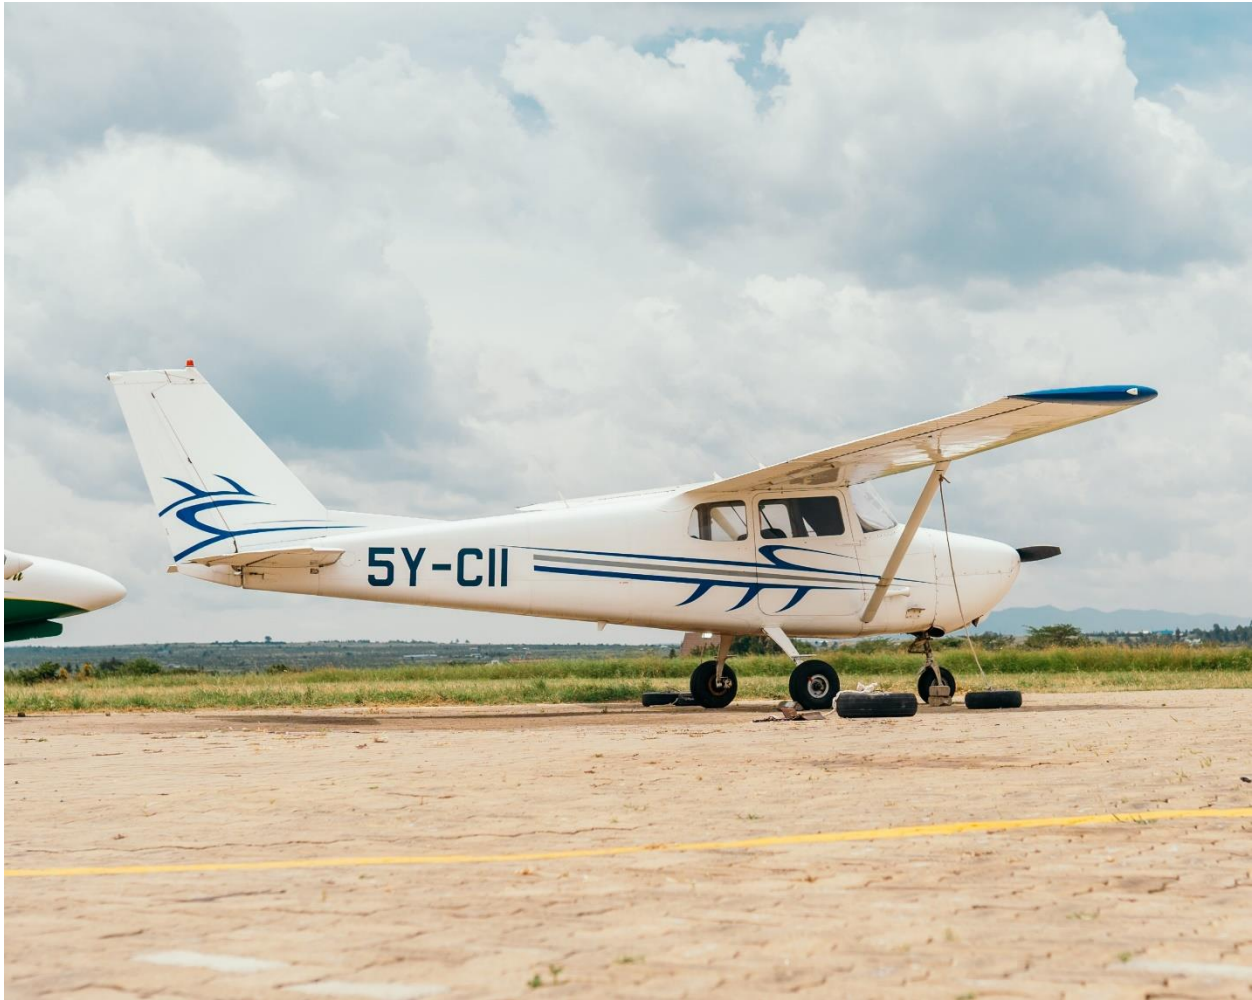
Figure 2: Photograph showing C172, Registration 5Y-CII at Wilson airport

The C172 registration 5Y-CII was registered on 20th February 2018. It had been issued with a certificate of airworthiness on 23rd February, 2022 valid until 22nd February 2023 with no limitations. Further information obtained indicated that scheduled maintenance was carried out on 18th July 2022 at 150 hours of inspection. By the time of the accident the aircraft had 2640 airframe hours and 2633 engine hours.
